**PRE-CONSTRUCTION CONDITION SURVEY REPORT
338 THIRD AVENUE, BROOKLYN, NEW YORK**

Re: Pre-Construction Condition Surveys
338 Third Avenue (Block 967, Lot 24)

PRE-CONSTRUCTION CONDITION SURVEY

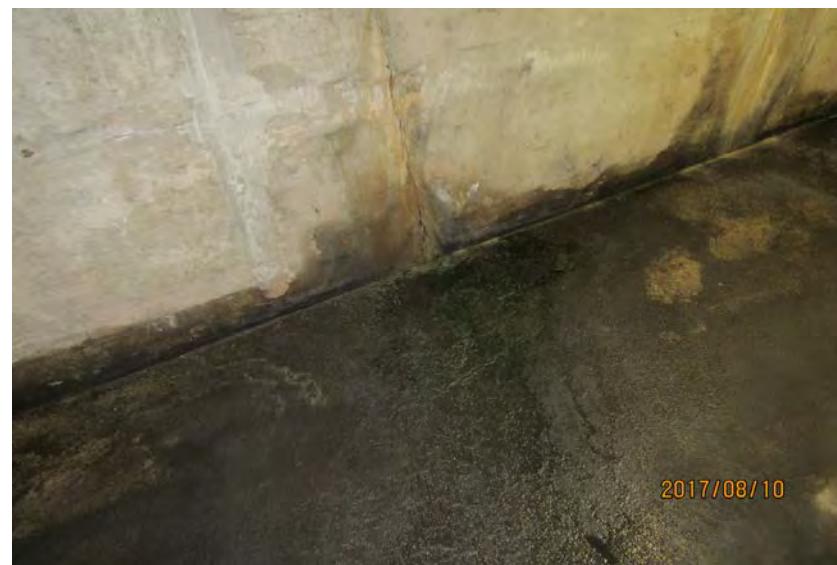
IMG_7224.JPG

Comments: Ov(7201), Water leak (7202), Crk wall (7203, 7204), Chipped bricks (7205, 7206), Spalling, Crk wall (7207~7222), Water leaks / water bonding (7222~7235), spalled, Holes in railing (7236~7242), Ov(7243), Chipped wall (7244), V+crk wall (7245), Crk / chipping wall (7246~7250), Ov(7251), Crk / chipping wall (7252~7255)
