**PRE-CONSTRUCTION CONDITION SURVEY REPORT  
420 CARROLL STREET, BROOKLYN, NEW YORK**

**PROJECT ID: PW77GOWAN  
EXCAVATION & CAPPING OF FILLED  
FIRST STREET TURNING BASIN, GOWANUS CANAL  
BROOKLYN, NEW YORK**

**November 30, 2017**

Re: Pre-Construction Condition Surveys  
420 Carroll Street (Block 453, Lot 1)

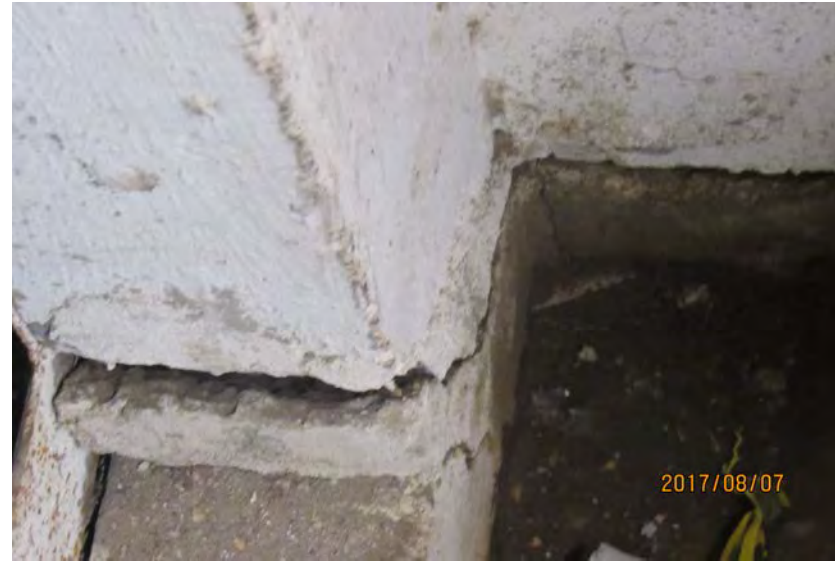
IMG\_5884.JPG

Floor / Location: 1st Floor Number of Windows 0  
 Room Use: Existing Storage 1 Ceiling:  Drywall  Suspended  Plaster  Wallpaper  Other Concrete  
 Walls:  Drywall  Paneled  Plaster  Wallpaper  Other Concrete  
 Photo(s):  Yes  No Floor:  Wood  Ceramic Tile  Other Tile  Other  
 Photo No's. 5876 ~ 5887  Concrete  Rug  Wall to wall carpet  
 OBSERVED DEFECTS:  None  Cracks (List size, type, location)  Other (Describe)  
 Comments: Ov. (5876), Dag Crk on Wall (5877, 5878), Vrt/Hz Crk (5879), Vrt Crk in Column (5880), Step crk corner of wall (5881), Step crk across hall (5882), Hole in wall (5883), Separation corner of wall (5884), Crk around door (5885, 5886, 5887),  
 See Comment No.

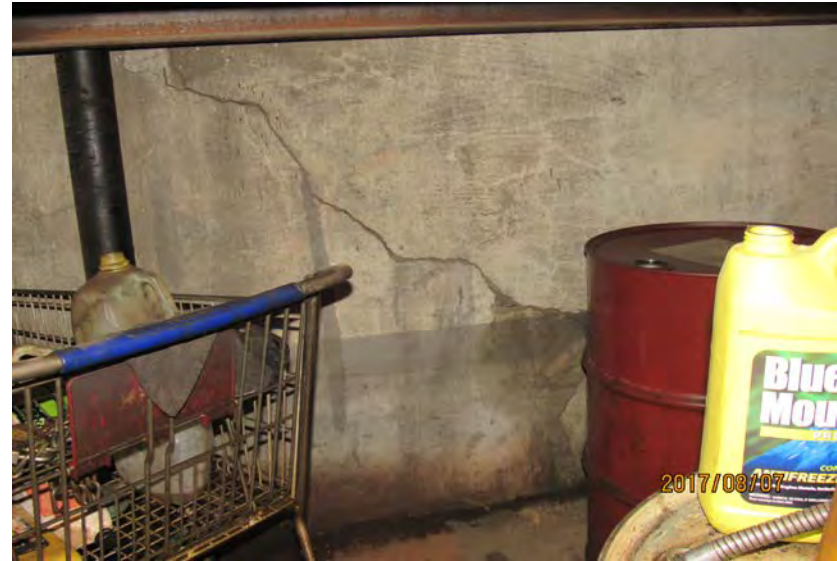
IMG\_5938.JPG

Comments: Patched Dag Crk (5938), Dag Crk in wall (5939), Step Crk (5940, 5941), Vrt. Crk (5942), Hole in wall (5943), Hole in wall (5944), Crk around pipe above door (5945), Patched Crk (5946), Crk around opening (5947, 5948, 5949, 5950, 5951), Damaged door frame (5952), Ov. NW (5953),

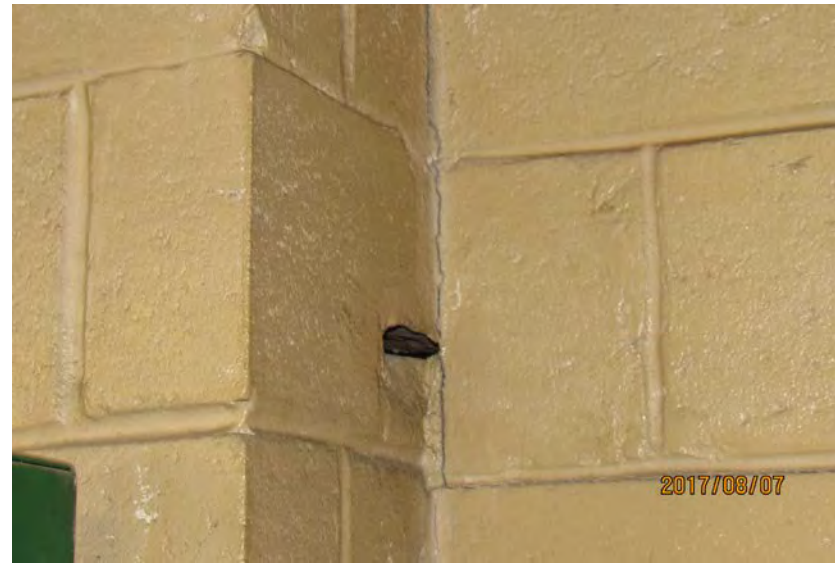
IMG\_5976.JPG

Comments: Dv (5972), Damaged floor tile (5973), Step Crk wall (5974), Crk around corner of wall (5975), Crk in wall near floor (5976), Hole in wall Crk (5977, 5978)

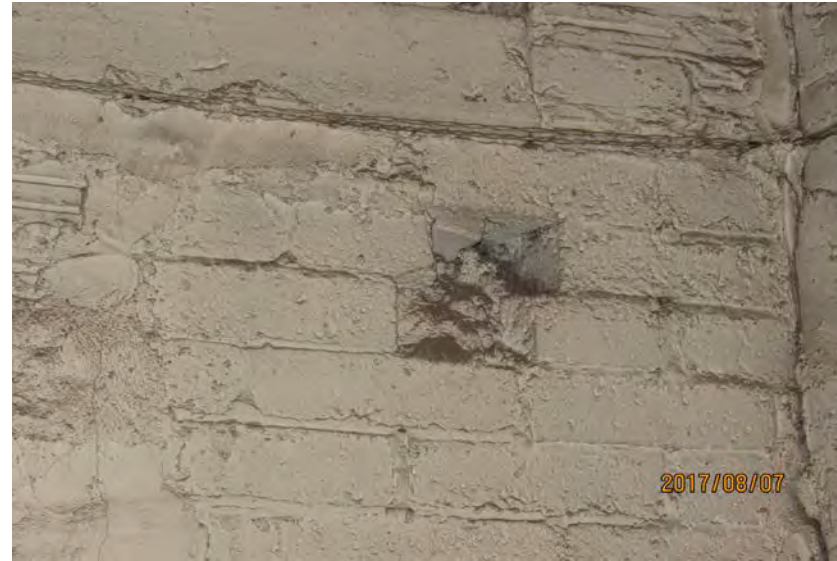
IMG\_6071.JPG

Comments: Chipped wall (6064), Hrz. crk close to ceiling (6065, 6066), Step crk (6067), Vrt. crk (6068), Missing brick around pipe (6069), Chipped wall (6070), Sep. above door (6071), Missing brick (6072), Vrt. Step crk (6073, 6074, 6075), Patched crk (6076), Sep. around door (6077),  See Comment No.

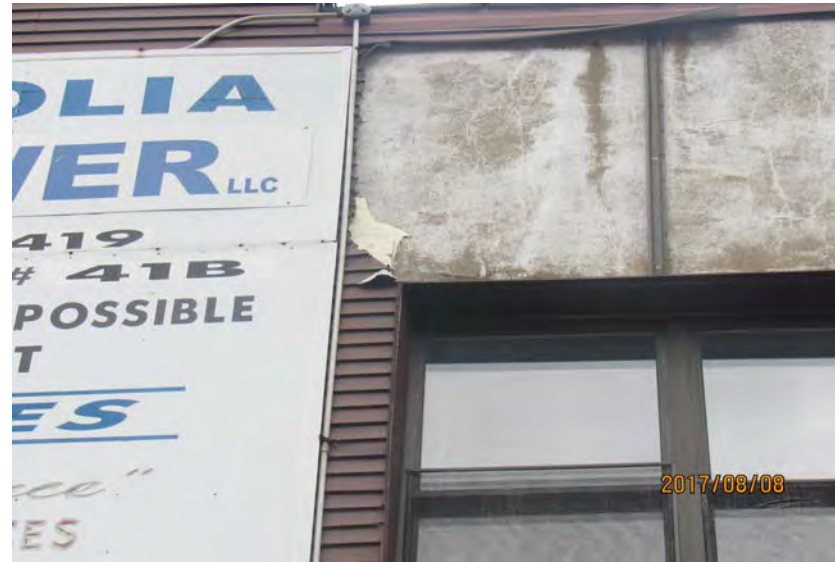
IMG\_6288.JPG

Comments: Dv (6287, 6288), Damaged wall (6289), Hole in wall (6290), Crk in wall (6291), Sep in metal sheet (6292 - 6296)  
metal sheet missing (6297, 6298), Hole in wall (6299), Rad chkd crk wall (6300, 6301), Crk around windows from (6302)  
Sep in double casing (6303), Metal sheet missing (6304), Vrt Crk top (6305)  See Comment No.

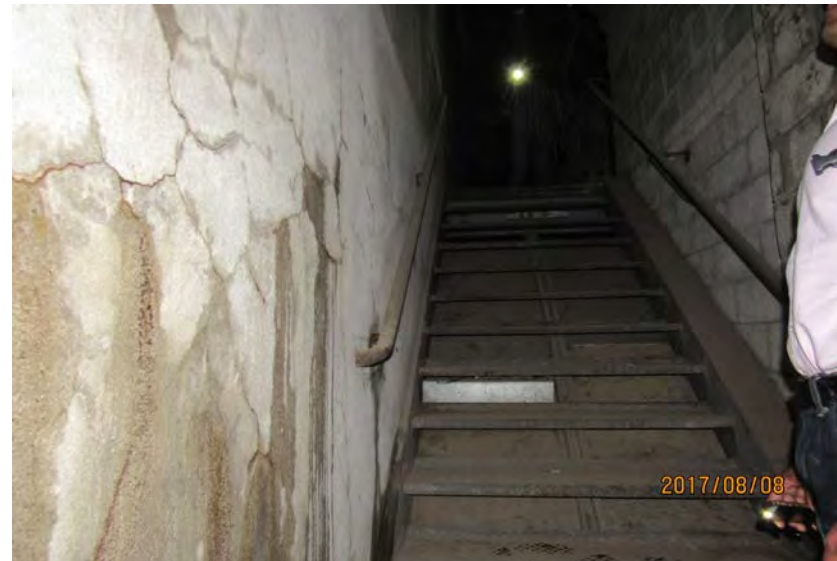
IMG\_6567.JPG

Comments: Dv (6566, 6567, 6568), Crk in wall (6569, 6570), water staining (6572), sep/crk in wall (6573, 6574, 6575, 6576), Vrt and step crk in wall (6577)

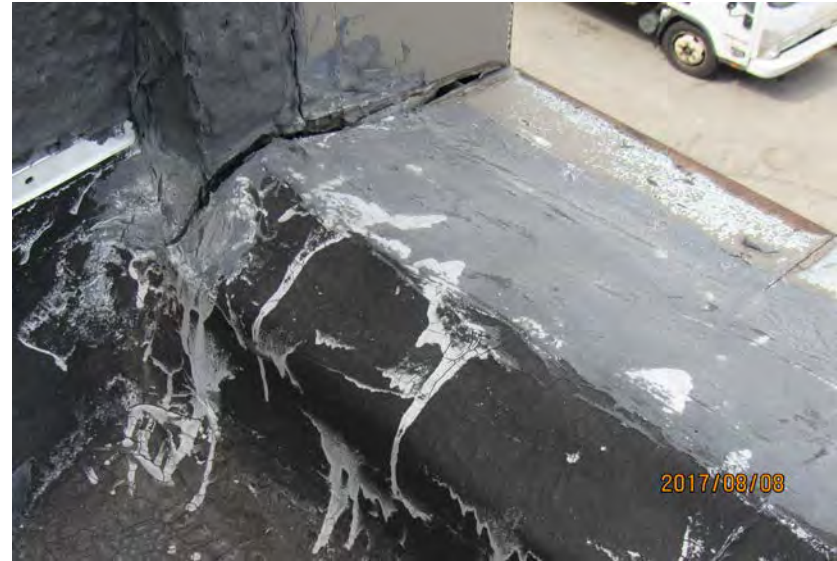
IMG\_6618.JPG

OK (6608-6610), r/a. & stepped cills on wall (6611-6616), damage in wall (6617, 6618), cracks and separation @ parapet (6619-6622)

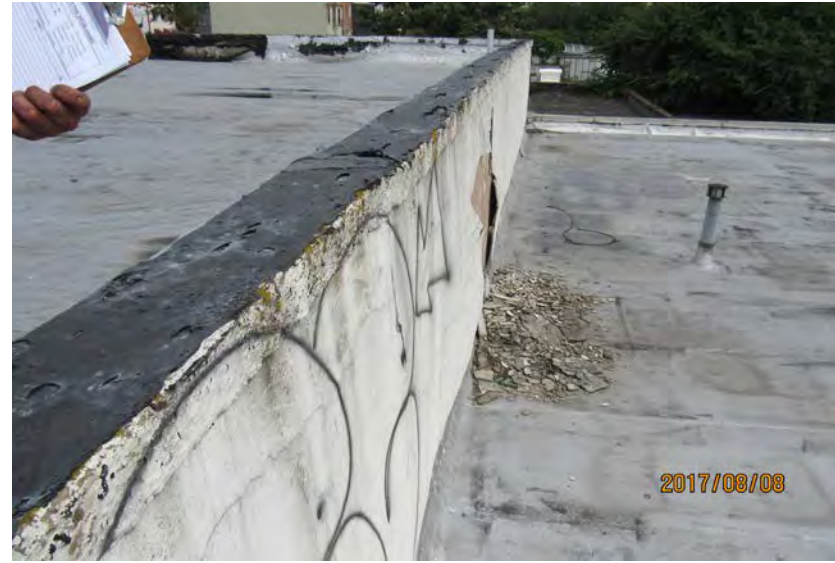
IMG\_6646.JPG

Roofs	1 <sup>st</sup> Floor	6627-34	Damage to aluminum roofing
		6640-6	Crack in bulkhead wall
		6647	Crack in kneewall
	2 <sup>nd</sup> Floor	6611-18	Cracks in walls, wall damage
		6619-22	Cracks at parapet
	3 <sup>rd</sup> Floor	6602-3	Cracks, damage to aluminum roofing
		6604	Vert. crack @ parapet
		6605-6	Cracks in skylight
		6607	Damage to clay tile cornice
