Memorandum

Subject: TB4 Pilot Study Observations during Bulkhead Support Installation

TB4 PILOT STUDY OBSERVATIONS AND FUTURE DESIGN IMPACTS:

GIKEN TRIAL

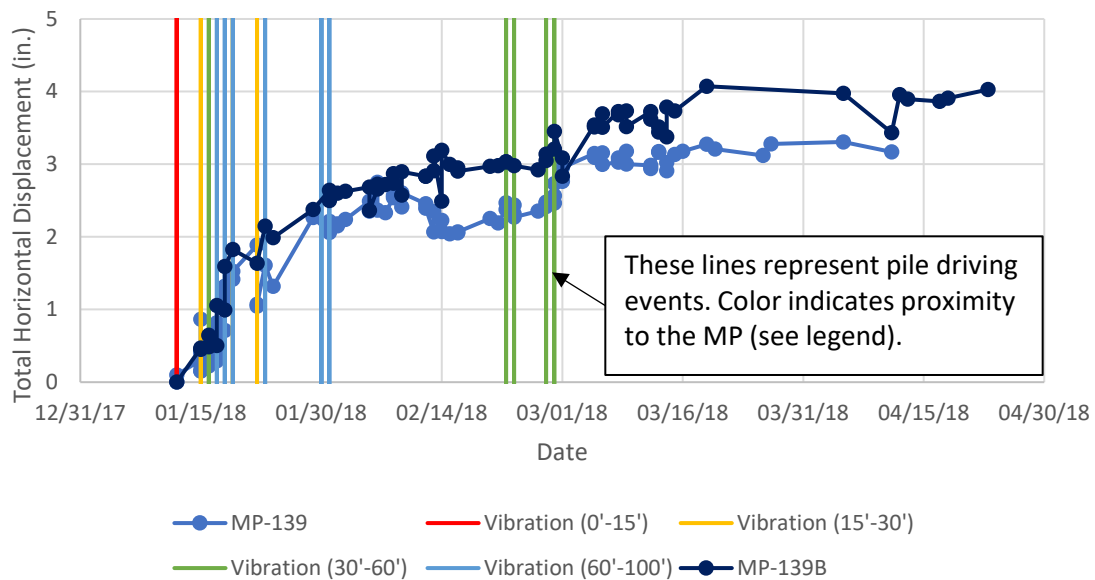
Vibrations from pile driving were monitored in real time. The frequency and force of the vibratory hammer was adjusted to limit the induced vibrations. Despite controlling the hammer and maintaining induced vibrations within target limits, at all locations adjacent to vibratory pile driving, settlement of the existing bulkhead and the development of cracks behind the existing bulkheads were observed. The rate of settlement and movement was greatest at the time of and shortly after the induced vibrations; however, they continued at a decelerated rate for weeks after driving. Furthermore, it was observed that the zone of

influence from the vibrations along the line of sheet pile installation is greater than 30 ft, as shown in Figure 1 and Figure 2. Monitoring point (MP) MP-139 and MP-139B are located on the existing bulkhead front edge and in the middle of the existing bulkhead, respectively. These points are located in the parking lot at 386 3rd Avenue. MP-139 is at the bulkhead face and MP-139B is approximately 10 ft behind the face. It appeared that movements continued for some time (on the order of several weeks to a couple months) after nearby pile installation is complete, indicative of material consolidation, possibly caused by vibration induced excess pore pressures. It was unclear within which soil units the movement was occurring.

Figure 1. Measured Lateral Displacement (towards TB4) at MP-139 and MP-139B during Vibratory Hammer Driving

Based on these observations, vibratory pile driving should be avoided along the Canal in areas within 40 ft of sensitive structures and utilities that cannot allow for several inches of potential lateral displacement and settlement. This criterion may limit the use of conventional pile driving methods to a select few locations along the Canal, requiring that alternative pile driving methodology be implemented.

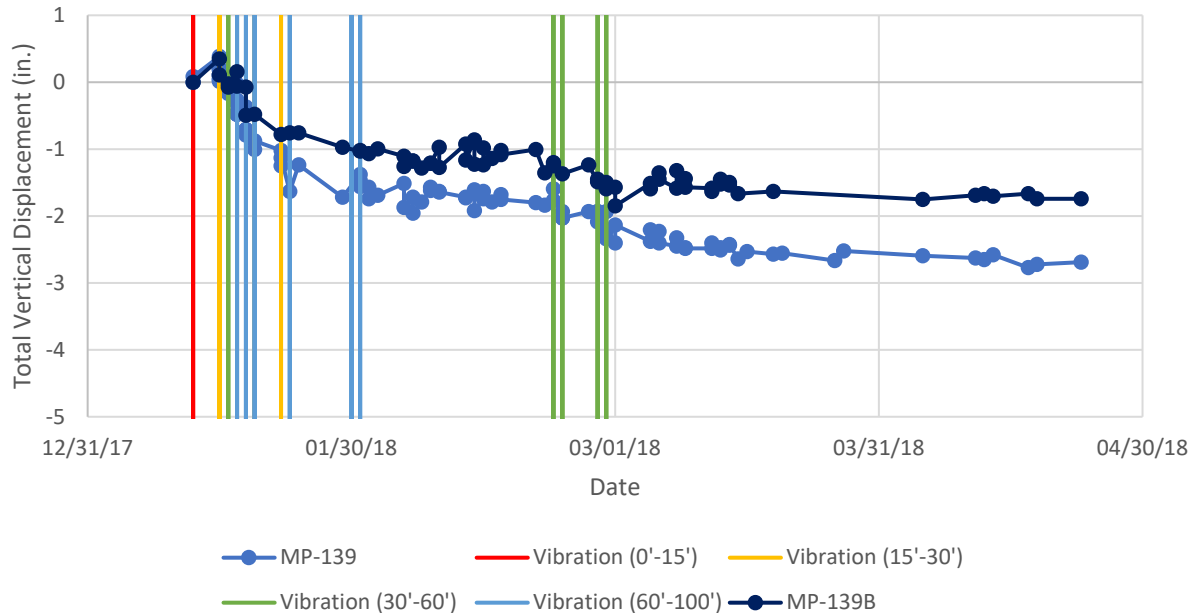
Figure 2. Measured Vertical Displacement at MP-139 and MP-139b during Vibratory Hammer Driving

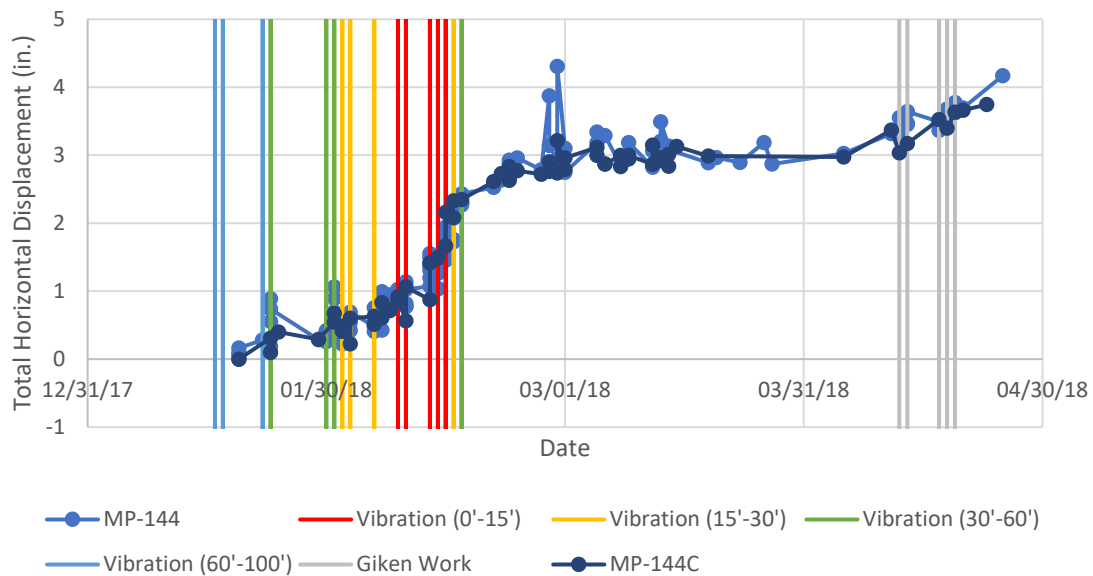
- Hydraulic impact hammers create vibrations that can cause movement of existing bulkheads.** A hydraulic impact hammer (Dawson HPH2400) was utilized in an attempt to reduce pile installation noise and vibrations. The hammer was tested at various stroke heights to identify the most efficient method of pile driving that did not cause excess vibrations. At a low stroke height, the hammer could not effectively drive the sheet piles through the glacial deposits which underlay the native alluvial sediments. At the mid-range stroke height, the sheet piles could be driven to target depths; however, settlement and displacement of the existing bulkhead was observed. Movements at the optical survey markers were similar in behavior to what was observed during vibratory pile driving, as shown in Figure 3 and Figure 4. As was the case for vibratory driving, it appeared that movements continue for some time after pile driving and it was unclear as to within which soil unit(s) movements were occurring. Structures within 20 ft of the pile driving, including those both in fair and poor condition, also developed signs of movement. The high number of blow counts required to drive the sheets caused the tops of the sheets piles to crush and disfigure. Additionally, the contractor had less control on the location and alignment of the piles installed and therefore required additional falsework as compared to vibratory sheet pile installation, as shown in Figure 5. The additional falsework reduced the production rate for sheet pile installation. Based on the observations made during the Pilot Study, hydraulic impact hammering should not be used for sheet pile installation

Figure 3. Measured Lateral Displacement at MP-144 and MP-144c during Impact Hammer Driving

within 40 ft of structures, and if used, requires extra falsework as compared to vibratory hammers to better maintain pile alignment and location.

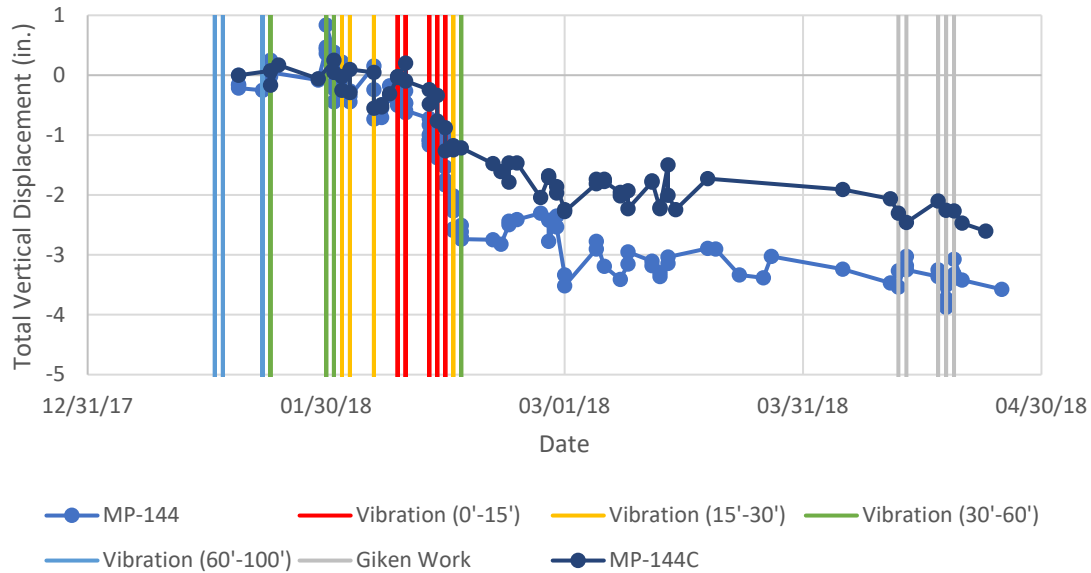
Figure 4. Measured Vertical Displacement at MP-144 and MP-144c during Impact Hammer Driving

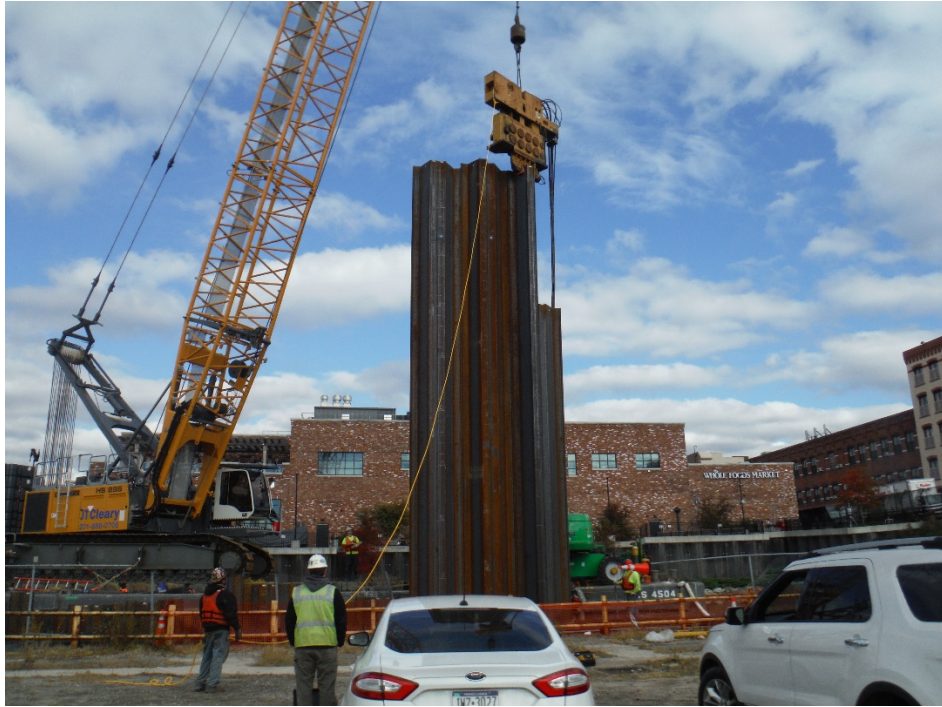
- **The panel driving approach should be avoided.** Use of the panel driving approach with either the 250VM or the 170VM led to noise exceedances and greater potential for upland disruptions. The panel driving approach involves setting up to four pile pairs in a line with the first (king pile) and last (queen pile) driven down about halfway. Then the gang piles (those in-between the king and queen piles) are driven down in sequence. Once the panel is about half-way down, the piles are driven to target depth in a stepped sequence. An example of panel driving is shown in Figure 6. The approach provides better control over pile alignment and improves drivability past obstructions and hard ground compared to installation of single pairs. However, the large number of sheets suspended in the air led to noise levels exceeding the suggested allowable criteria as the sheets rattled in the interlocks during driving. Noise levels were reduced by modifying the installation approach to a single pair of sheets and using the smaller, 170VM.

Figure 6. Example of Panel Pile Driving

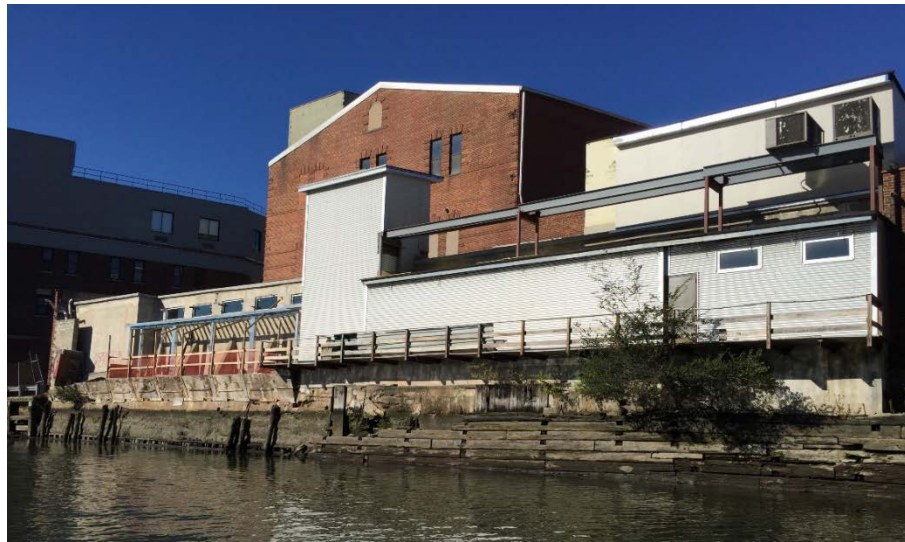
The spatial requirements of the Giken equipment means that the Giken will not be able to install piles immediately adjacent to existing bulkheads that have structures or walls along

the bulkhead edge; an example of such a situation is presented in Figure 2. In such situations, an offset up to six feet from the existing bulkhead will be required with the Giken, depending on the upland obstructions. It is estimated that 14% of bulkheads along the Canal cannot be directly accessed with the Giken.

Figure 2. Photo of Property in RTA2 with Structure Immediately on and Cantilevering over Existing Bulkhead

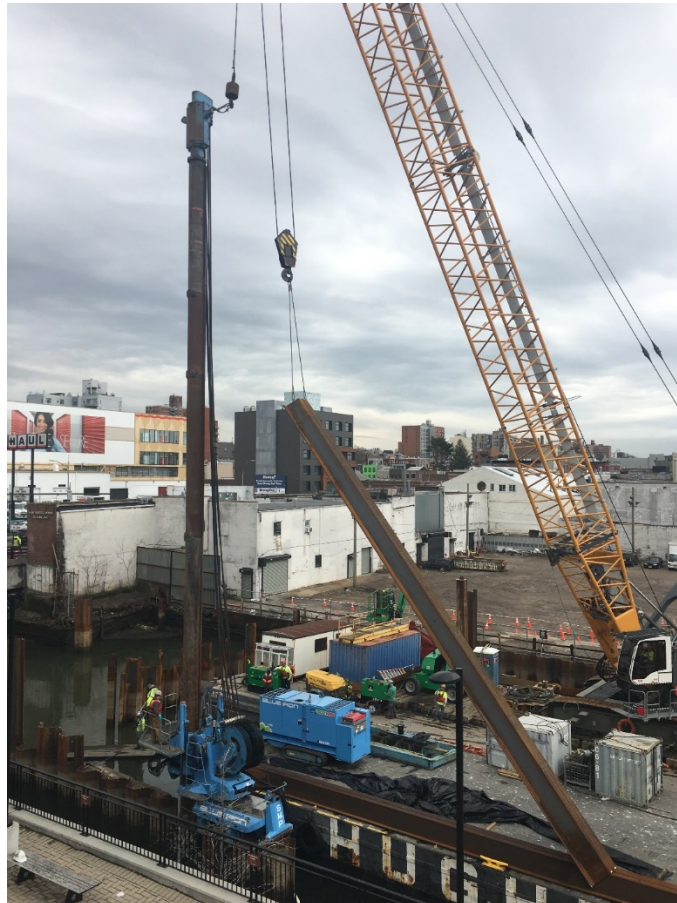
3. Overall, during the installation of a single pile pair in TB4, an extra 60 to 90 minutes was necessary to maneuver the auger compared to the simpler press method, reducing production by at least 50%. This extra time is broken down as:

- Because of limited working space available in TB4, the same crane that supported the auger was required to also lift the sheet pile pair to be installed. This is a challenging maneuver that can take 15 minutes to complete.
- The auger and sheet pile pair must be welded to each other to ensure that the auger does not “walk” and advance away from the piles. Welding takes approximately 20 minutes.
- After a pile is installed the auger must be lowered before the Giken can proceed to the next position. Lowering and raising the auger can take 10 to 20 minutes each time (10 to 20 minutes for lifting and 10 to 20 minutes for bringing it back down).
- At the beginning of the work day with the auger, the auger hoses must be connected to the machine. This can take up to 20 minutes and is a required maneuver if the Giken machine needs to be lifted or moved.

Figure 3. Photo of Crane Lifting Sheet Pile while Holding the Auger

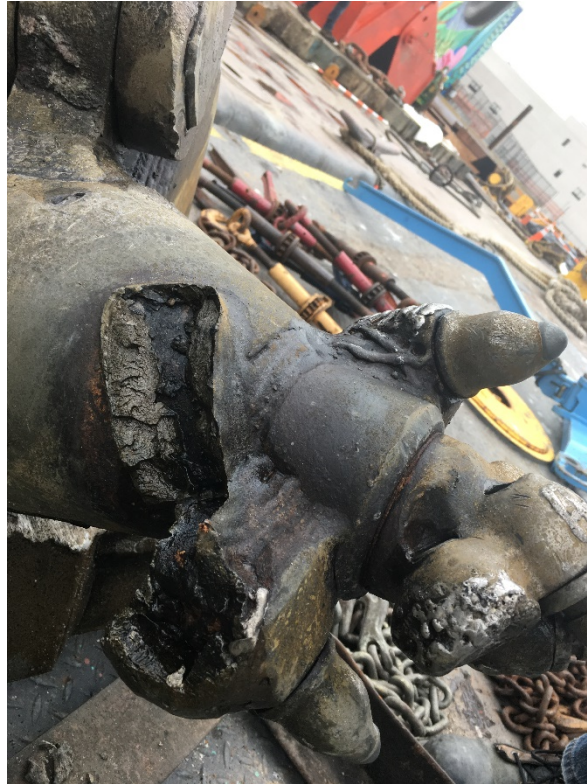
Metal obstructions damaged the auger head on multiple occasions. During installation of the six pile pairs, the auger head was severely damaged twice and required complete replacement; Figure 4 is an example of a damaged auger head. Auger head replacement represents a substantial delay in schedule as it can take about half a work day to remove and replace. It is not feasible to use the auger to drill and break down hard debris such as metal and concrete.

Figure 4. Photo of a Damaged Auger Head

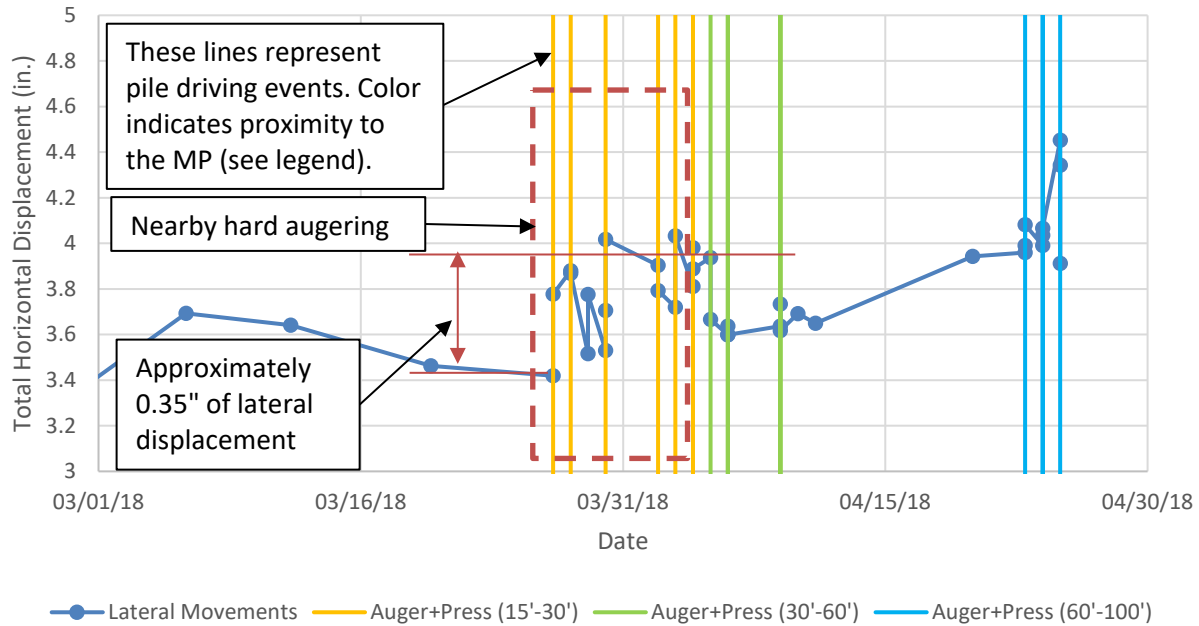
Furthermore, hard drilling has been observed to create vibrations at levels below the exceedance threshold but nevertheless measurable at nearby bulkheads and structures, potentially leading to incremental movement of the existing bulkhead. Vibration induced movements from hard augering were observed at monitoring point (MP) 104, near bulkhead support station 5+75 along the Whole Foods bulkhead. Lateral displacement and vertical displacement plots are shown on Figure 5 and Figure 6, respectively. Therefore, continued use of the auger is not recommended when hard grinding like drilling is encountered. Rather, augering should cease and the pile pair should be advanced to refusal by the press method.

Figure 5. Measured Lateral Movements at MP-104 during Hard Augering

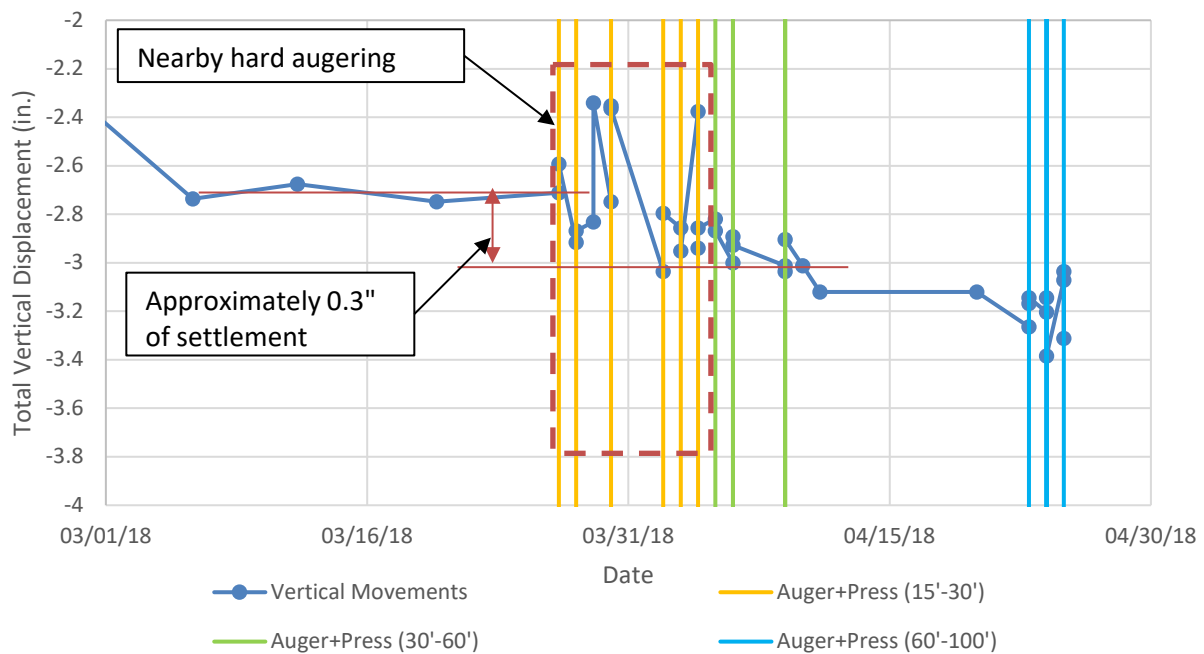
Figure 6. Measured Vertical Movements at MP-104 during Hard Augering

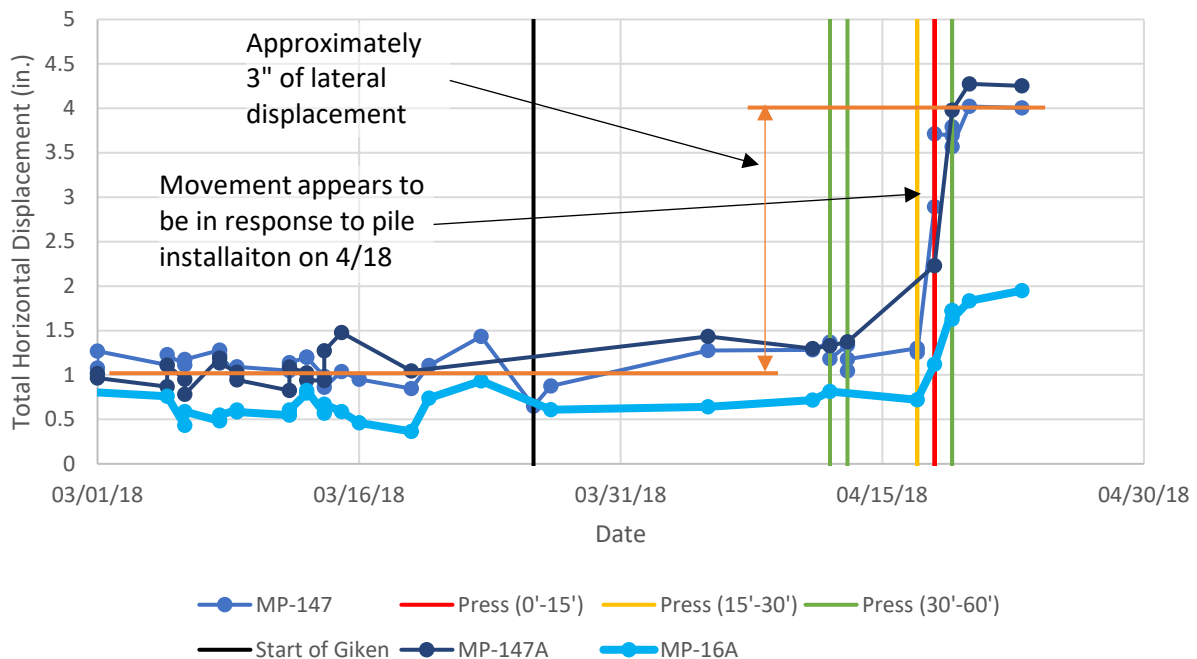
- **The press method can cause movements of adjacent existing bulkheads.** Throughout installation, the press method produced less vibration than press and auger method; however, movements of existing bulkheads were still observed on occasion. During driving at Dykes Lumber movement was observed in both areas where existing piles were pulled and replaced, and in areas where piles were only replaced (no existing piles required removal). An example area of where only pile installation with the press method is shown in Figure 7. The measured movements are presented in Figure 8 and Figure 9 near MP-147. MP-147 and MP-147A represent optical survey points on the existing bulkhead and MP-16A represents a point on the Dykes Lumber structure's foundation. At these monitoring points it was observed that the existing bulkhead shifted downward and towards the Canal on April 18th. On this date, six pile pairs were pressed. The pile installation process observed on this date was similar or faster (lower resistance) than that observed on previous days, with no indication of encountered obstructions in shallow reaches and hard driving not being encountered until elevation -50 or deeper. Therefore, the mechanism and cause of the movement is unclear. Additional movements at points near MP-147 are shown in Figures 10 and 11.

Figure 8. Recorded Lateral Movements during Giken Trial at MP-147

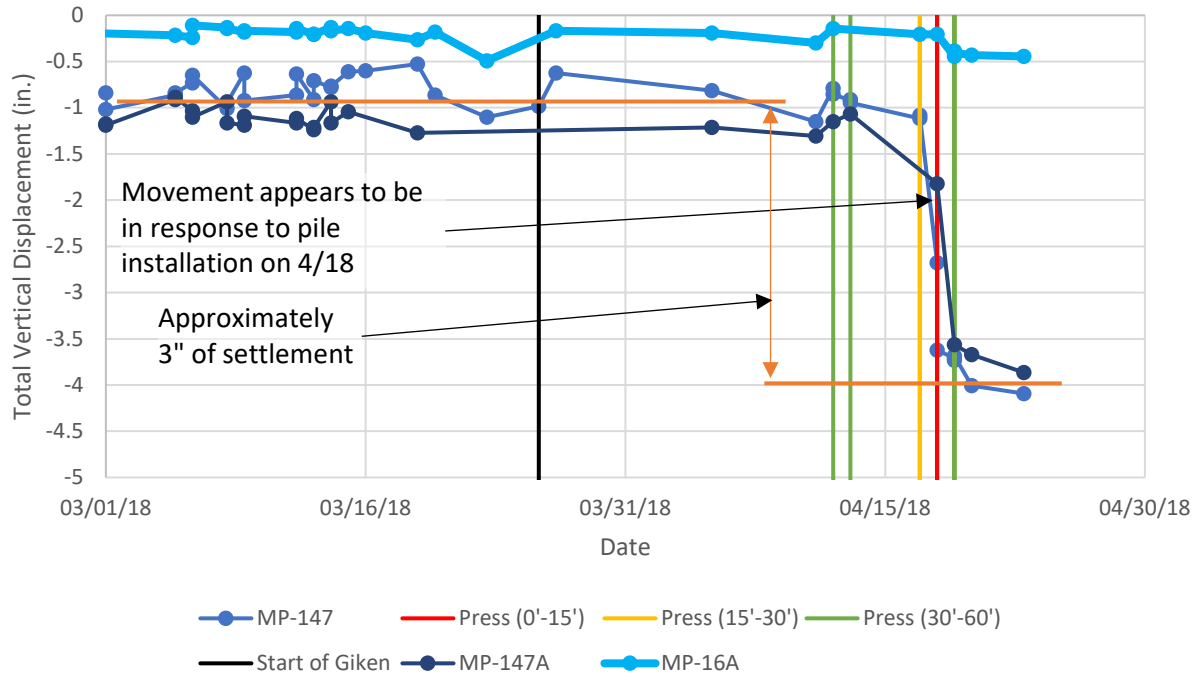
Figure 9. Recorded Vertical Movements during Giken Trial at MP-147

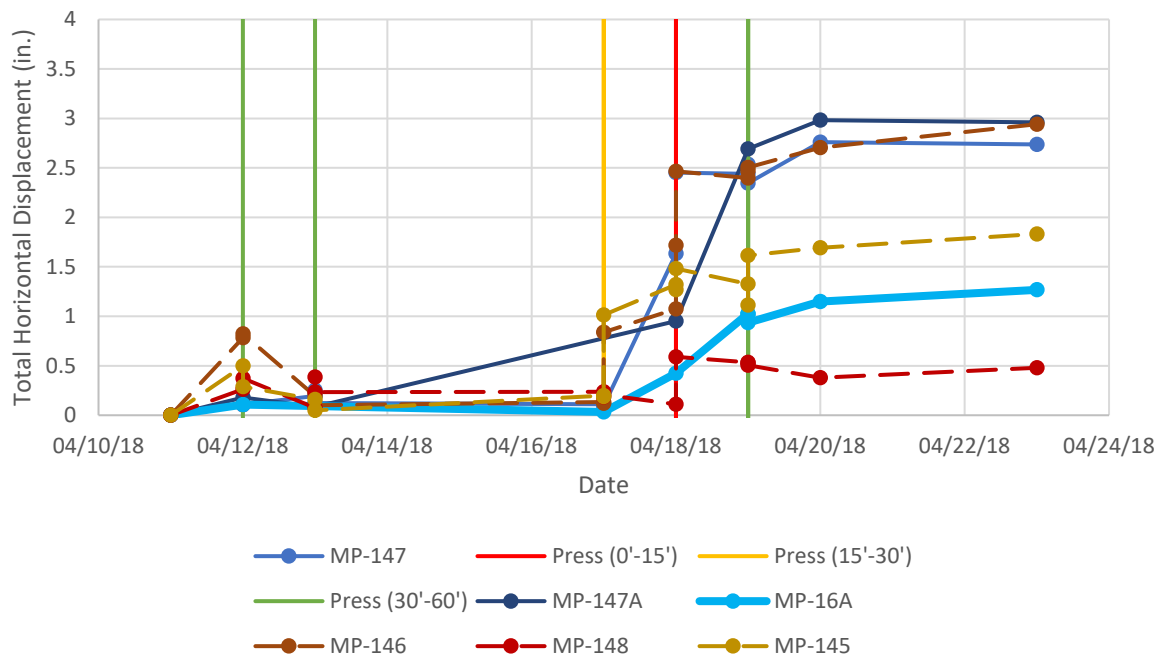
Figure 10: Recorded Lateral Movements during Giken Trial at and near MP-147

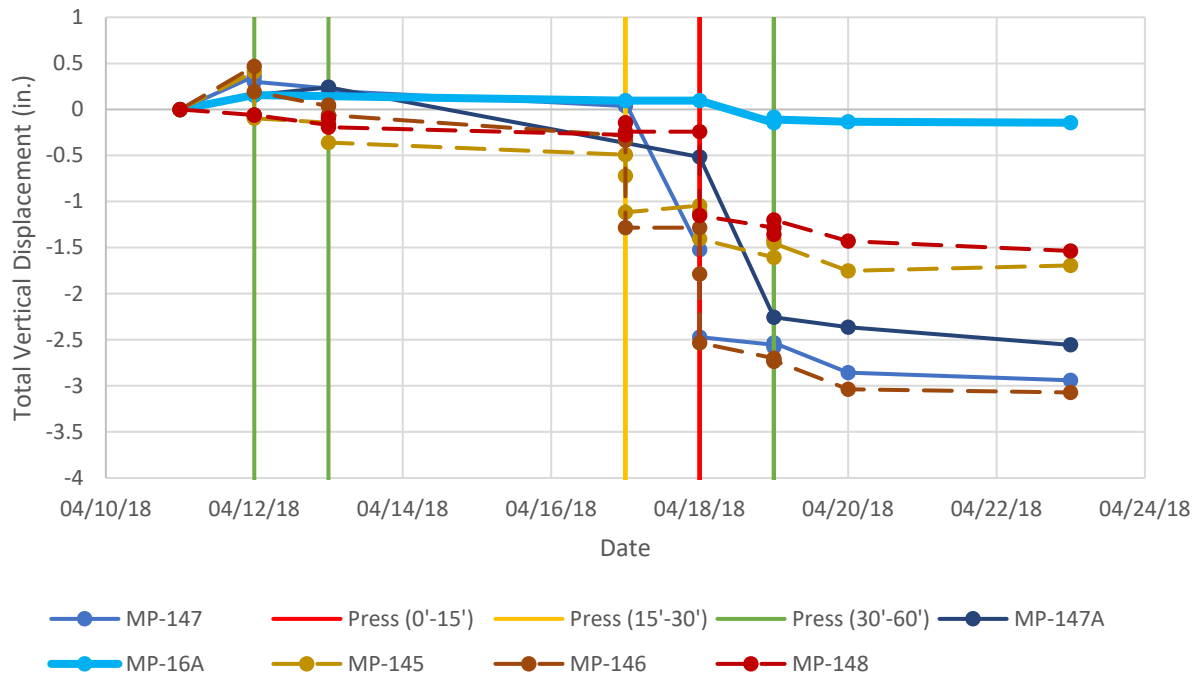
Figure 11: Recorded Vertical Movements during Giken Trial at and near MP-147
