ARCHAEOLOGICAL MONITORING REPORT

30% FIELD ACTIVITIES, RESTORATION OF FIRST STREET TURNING BASIN GOWANUS CANAL

BOROUGH OF BROOKLYN, NEW YORK

JANUARY 2018

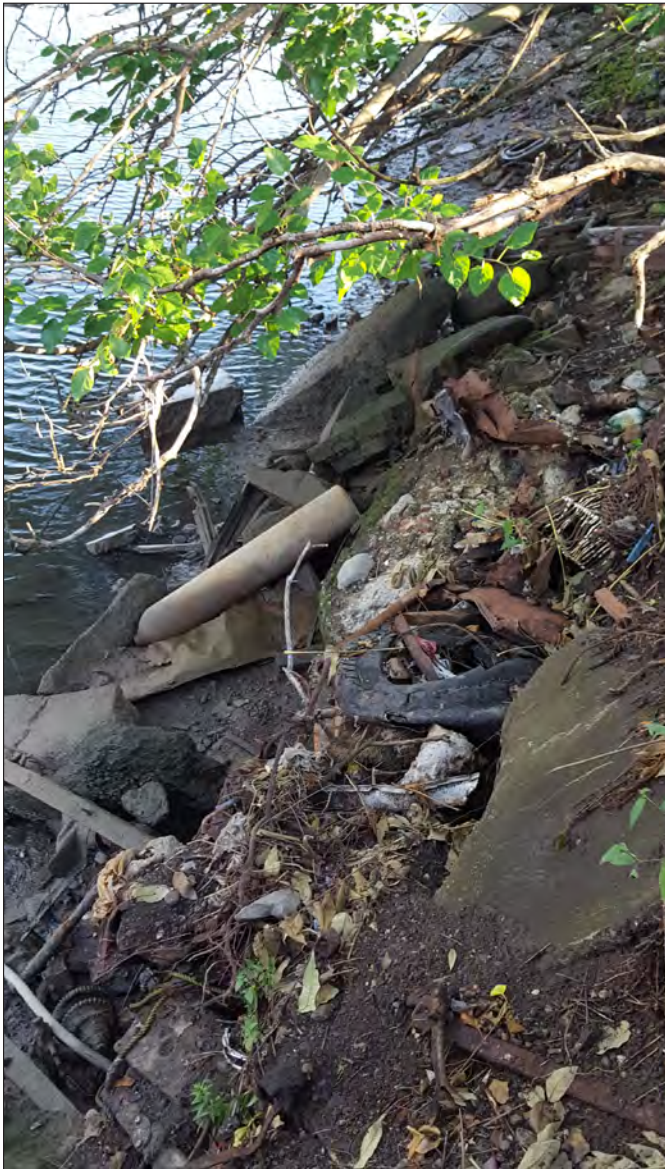
1

Facing north along the western edge of the filled-in 1st Street Turning Basin showing accumulated debris, loose soils spilling into the canal, and the absence of a retaining wall.

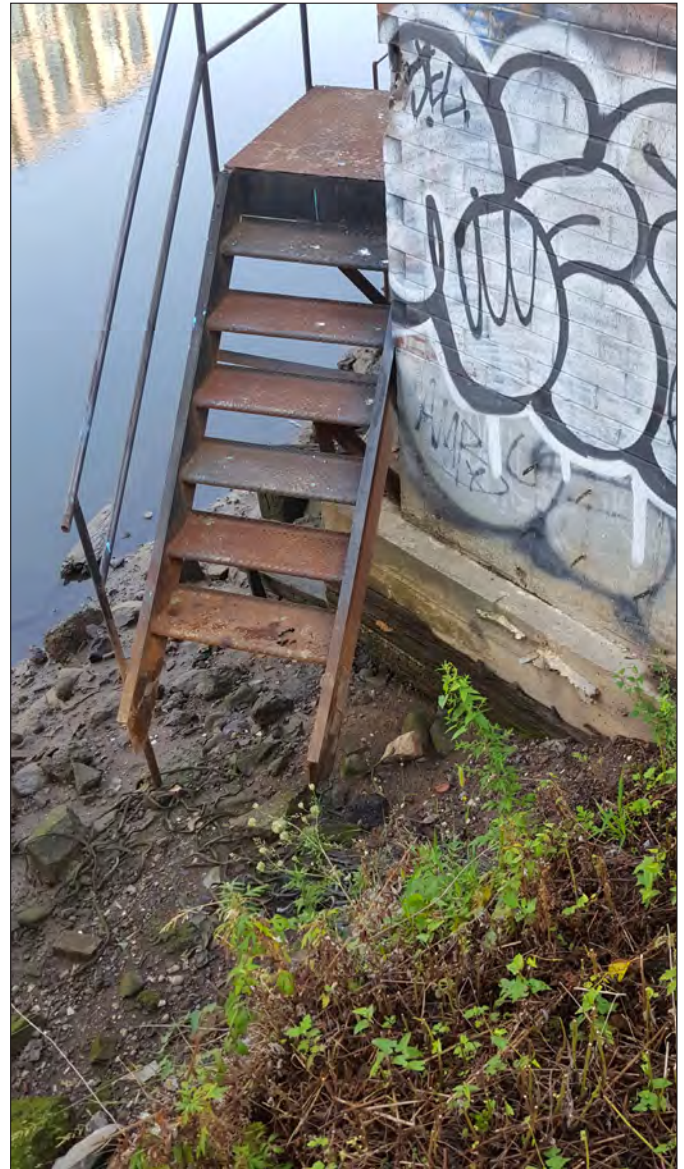
2

Facing northwest towards foundation of brick building located adjacent to northern edge of basin at its western end. Building is supported by a concrete foundation with a wooden fender.

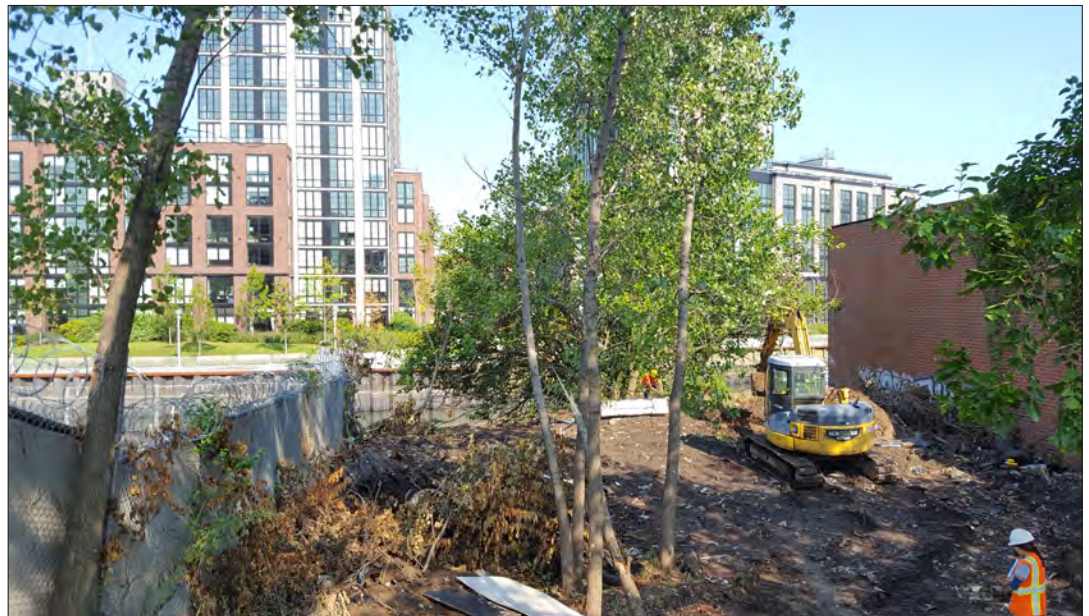
Test Pit 1 was excavated at the western end of the former basin, close to where it formerly adjoined the canal (Figure 3 and Photograph 4). The soils of this 8-foot bgs test pit consisted entirely of loose sandy fills and a high concentration of modern refuse including plastic sheeting, furniture, rugs, car parts, and modern packaging material (Photograph 9). No archaeological resources were observed in Test Pit 1.

Test Pit 5 was excavated towards the western end of the former basin adjacent to the expected location of the northern bulkhead, at the base of a modern brick building (Figure 3 and Photographs 4 and 20). This large 12-foot-square test pit encountered loose sandy fills and modern refuse such as automobile parts to a depth of 6 feet bgs. Though the field archaeologist observed no evidence of the bulkhead, they did encounter the brick building's foundation, which consisted of a 3-foot thick concrete slab supported by a 2.5 foot-wide by 2.5 foot-deep concrete footer, which was supported by at least one timber pile (Photographs 22 and 23). The soils adjacent to the concrete footer beneath the foundation consisted of loose mixed fill containing modern refuse including plastic. No archaeological resources were observed in Test Pit 5.

Facing west towards western portion of filled-in basin. The former turning basin originally extended from approximately the brick building on the right to the chainlink fence on the left.

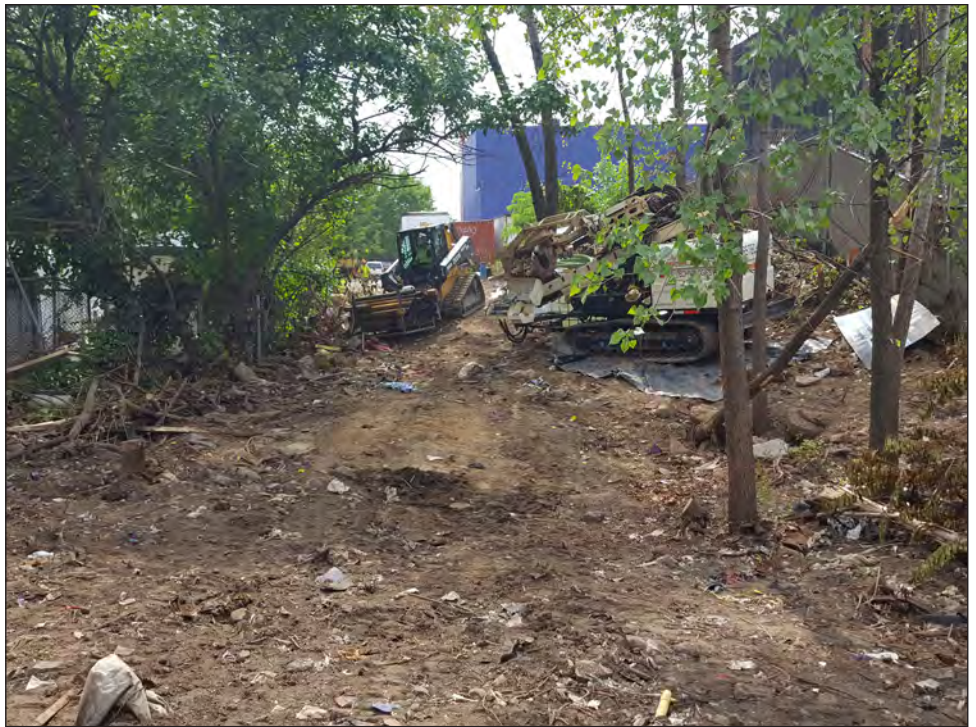
5

Facing east along filled-in turning basin from western half. Topography is irregular in this area. CubeSmart Self Storage on 3rd Avenue is visible in the background.

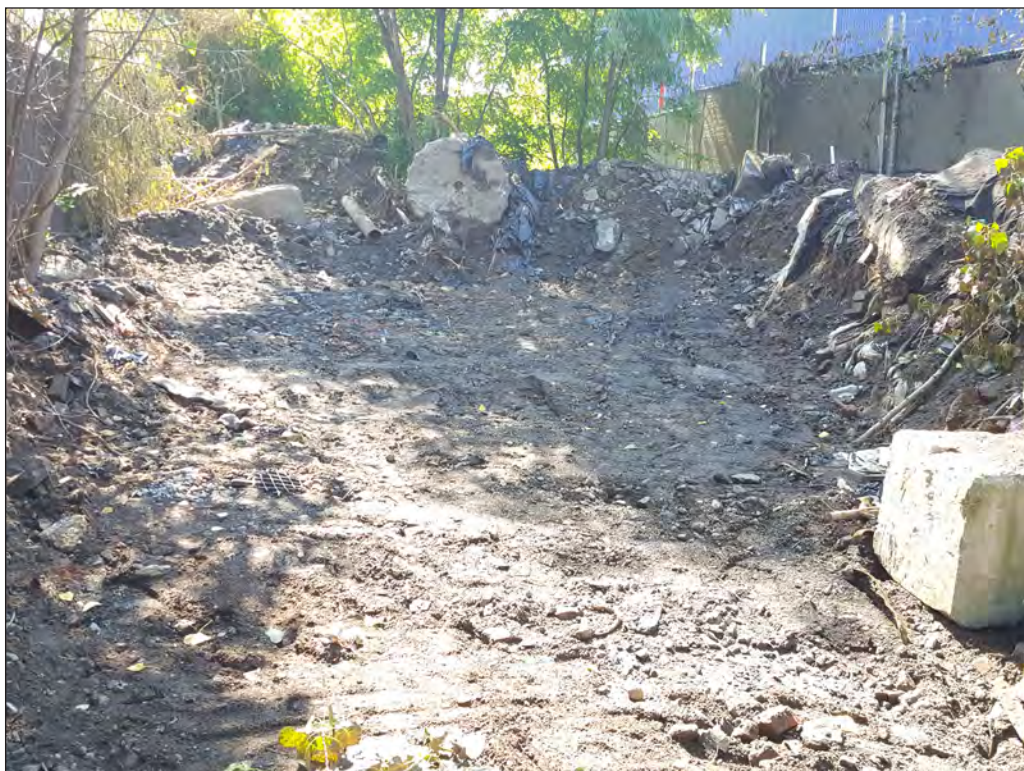
7

Facing east from the eastern un-paved portion of the filled-in basin. TP4 was excavated in this area.

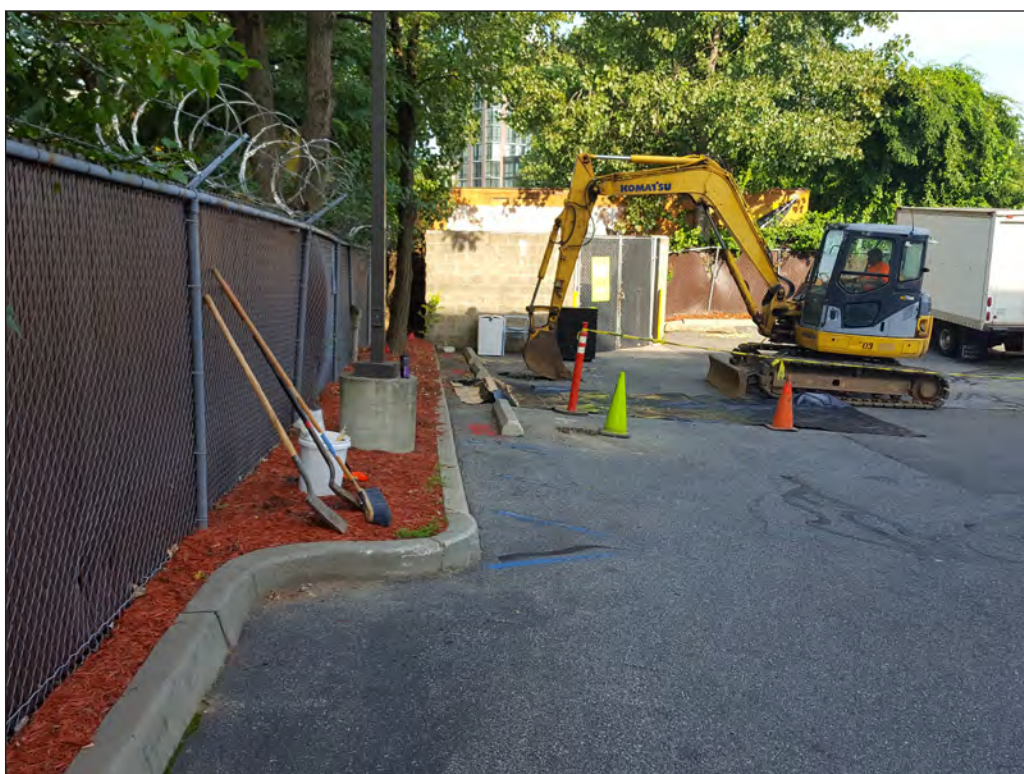
8

Test Pit 6 was excavated in the parking lot of a storage facility at the eastern end of the former basin and it was positioned at the anticipated location of the northern bulkhead wall (Figure 3 and Photograph 8). This test pit extended several feet beyond the anticipated bulkhead location to the area where timber cribbing filled with cobbles has been encountered along other portions of the canal. The field archaeologist observed no evidence of the bulkhead or timber cribbing. The encountered soils consisted of layers of loose, mixed sandy fills and thick layers of demolition debris (Photographs 23 and 24) to a maximum depth of 13 feet bgs, deeper than any of the other test pits. Excavation encountered three north-south oriented utility lines with diameters of 2 to 6 inches at a depth of 5 to 6 feet bgs. The utility lines had been abandoned but appear to be in their original location. No archaeological resources were observed in Test Pit 6.

Facing west from within the Extra Space Storage storage facility parking lot located north-east of the filled-in basin. The northern edge of the basin was likely located somewhere between the front of the excavator and the curb line.

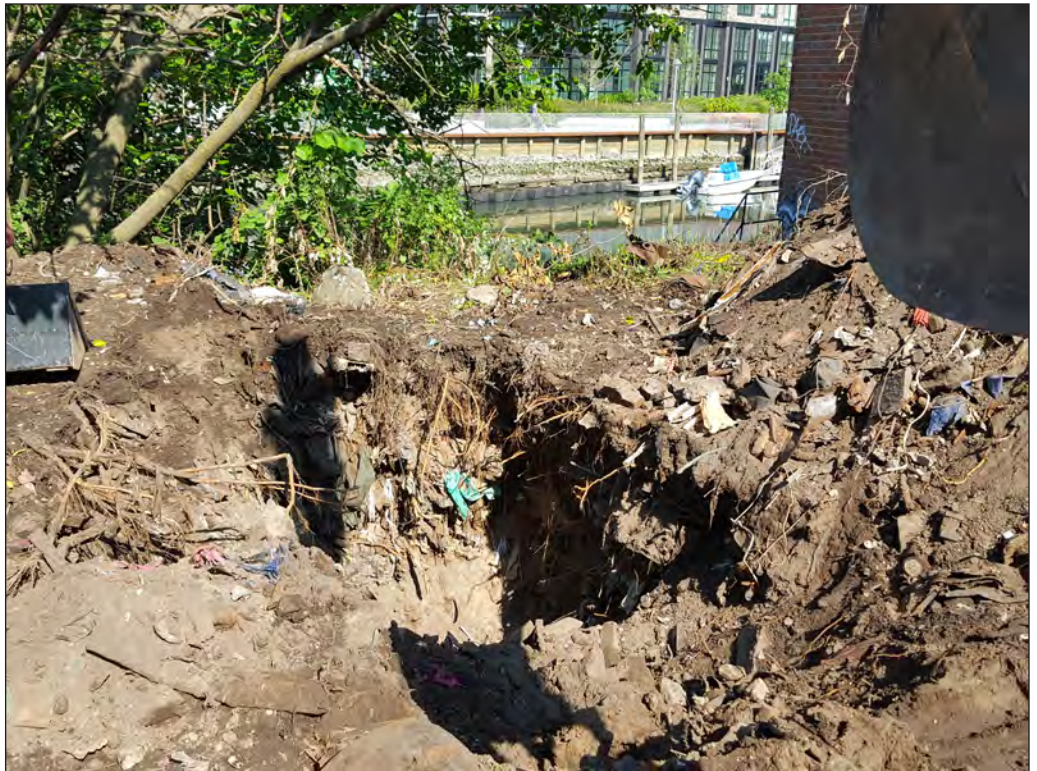
9

Facing west showing completed excavation of TP1. Note loose sandy fill and extensive modern refuse. The Gowanus Canal is in the background.

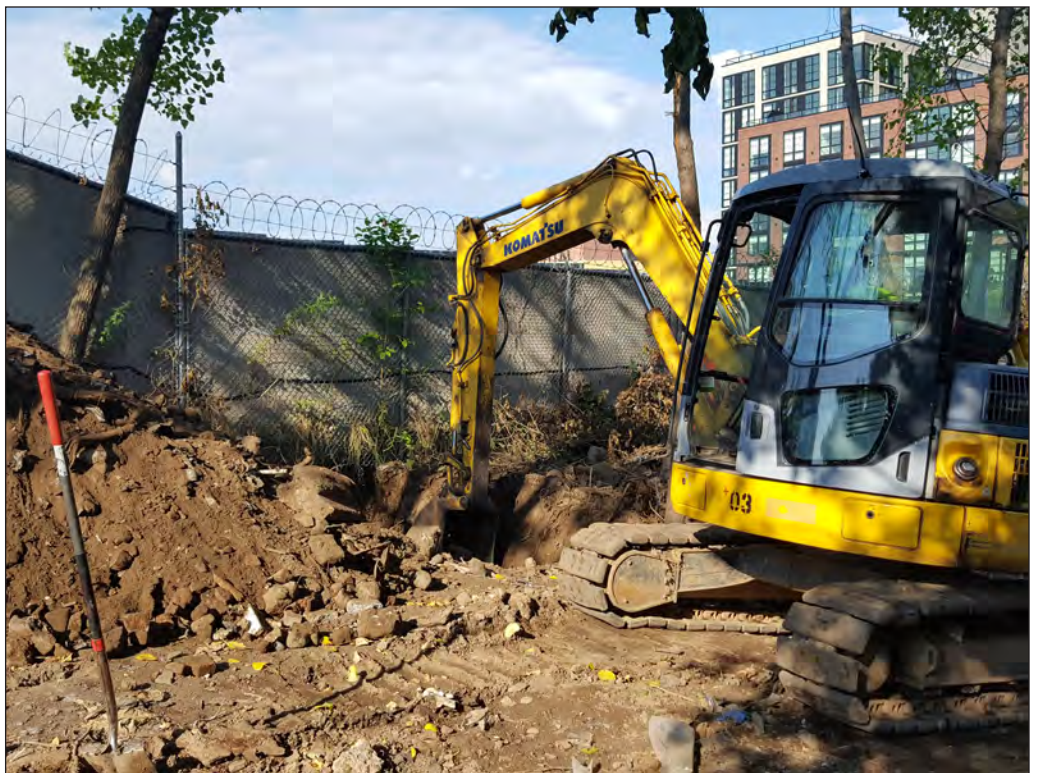
Test Pit 2 was excavated in the western portion of the former basin adjacent to the chain-link fence aligned with boundary between the former basin and the Powerhouse property to the south (Figure 3 and Photograph 10). Below an approximately 5-foot-thick layer of loose brown sandy fill, the excavation encountered a 1-foot-thick slab of decomposing concrete. The concrete slab was encountered below and parallel to the chain-link fence. Below the concrete slab, careful hand and mechanized excavation revealed a bulkhead comprised of a series of horizontally-oriented squared timbers (Photograph 11). At this point the test pit was widened to the west to a total width of 10 feet and excavation proceeded to a total depth of 9 feet bgs. The test pit sloped upward to the ground surface to the north and west to allow access to the bulkhead. An approximately 8-foot-long portion of the bulkhead was exposed, which consisted of a series of three courses of squared timbers (two of which had a diameter of 12 inches and one had a diameter of 9 inches), though the bulkhead likely continues deeper; the timbers were held together with a series of 1-inch diameter iron spikes (Photographs 12 through 14).

Facing southwest showing excavation of TP2 at base of chain-link fence extending along southern edge of turning basin.

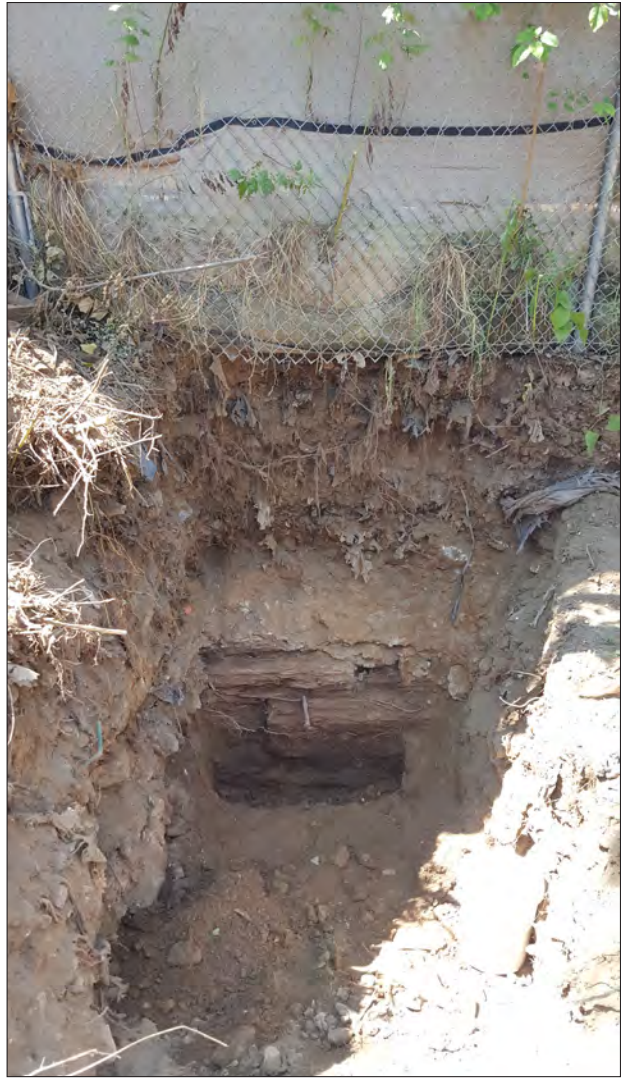
11

The condition of the exposed timbers was poor and they exhibit moderate to severe rot. The concrete slab is in similarly poor condition. Despite the fragile condition of the bulkhead it appears to be structurally intact and its burial beneath several feet of soil will likely protect it from further decay.

Facing south into TP2 showing portion of wooden bulkhead beneath concrete wall approximately 5 feet below base of fence.

It is recommended that archaeological monitoring occur during implementation of the RA to document any buried ship hulls present on the bottom of the filled-in basin. However, due to the poor condition of the portion of bulkhead observed within the basin during this monitoring effort and its similarity to extant bulkheads to the north and south of the basin along the canal, consultation with SHPO and LPC is recommended to determine the need for documentation and relevant research questions.

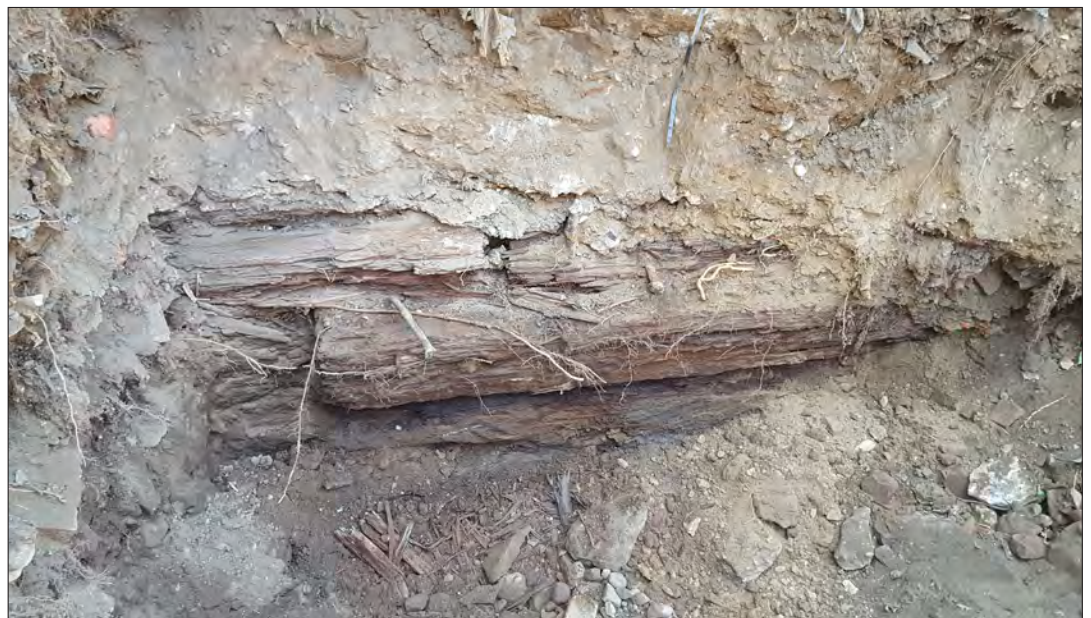
12

- The intact portion of bulkhead encountered in Test Pit 2 was in poor condition. This observation suggests that other intact portions of the bulkhead present within the basin may also be in poor condition.

Facing south in TP2 showing portion of wooden bulkhead and fasteners beneath decomposing concrete wall approximately 5 feet below base of fence. Three separate horizontal squared timbers are visible. Base of trench is approximately 9 feet below ground surface.

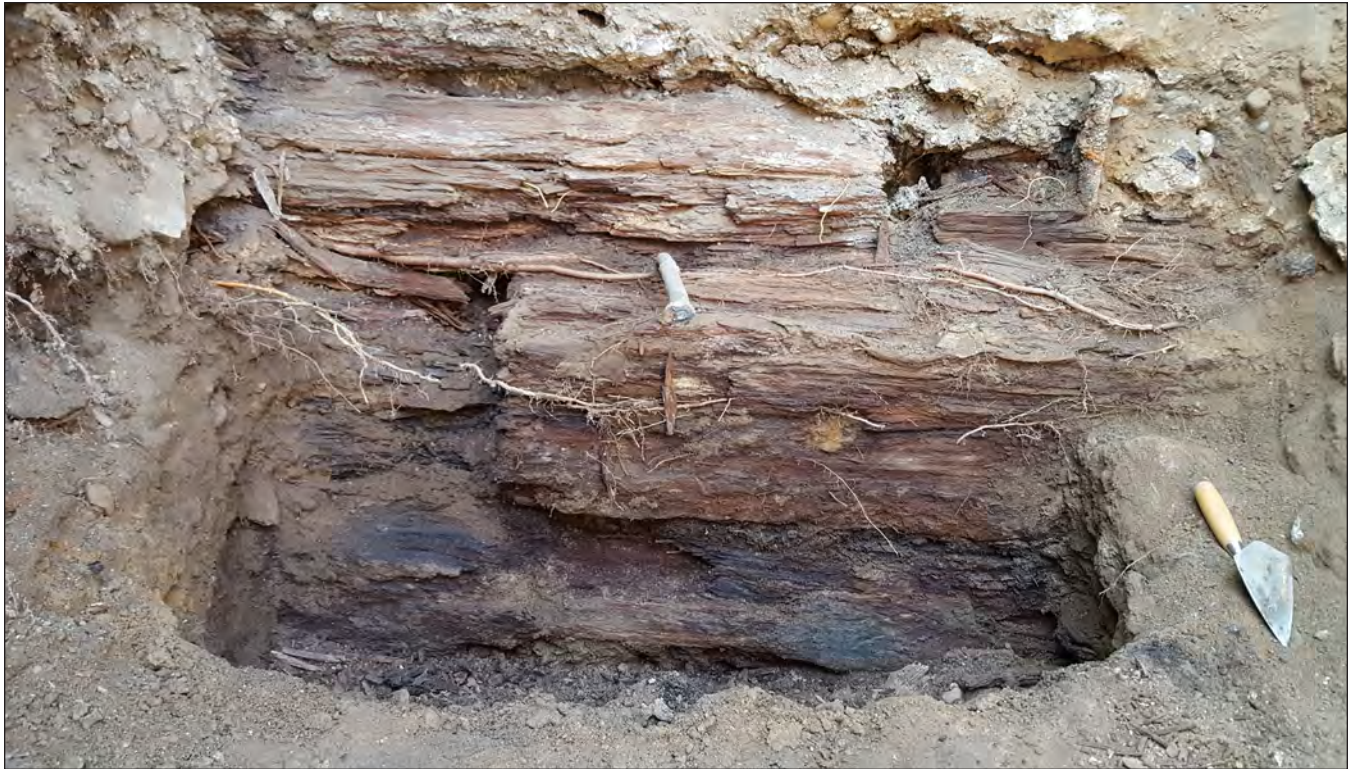
13

Facing south in TP2 showing portion of wooden bulkhead and fasteners beneath decomposing concrete wall approximately 5 feet below base of fence. Three separate horizontal squared timbers are visible.

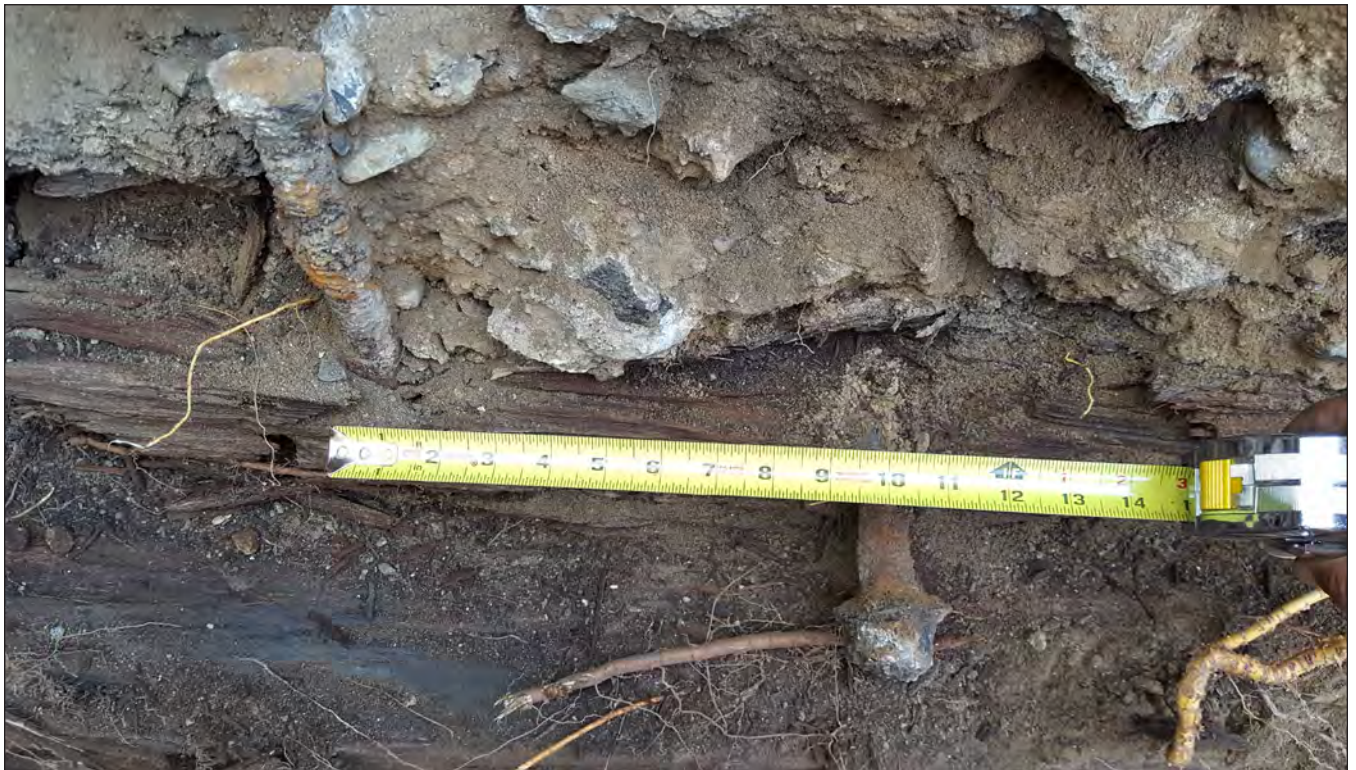
14

Detail of metal fasteners extending into wooden bulkhead in TP2, immediately below decomposing concrete wall.

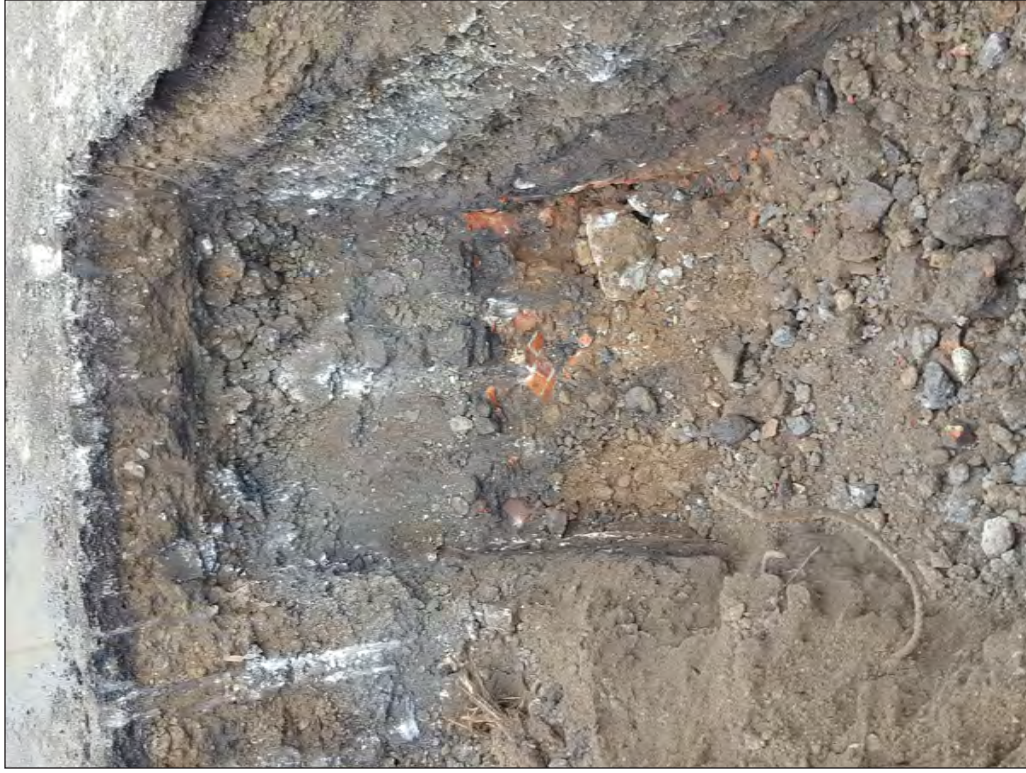
15
Facing south into partially excavated TP3. Note multiple layers of fill and brick demolition debris.

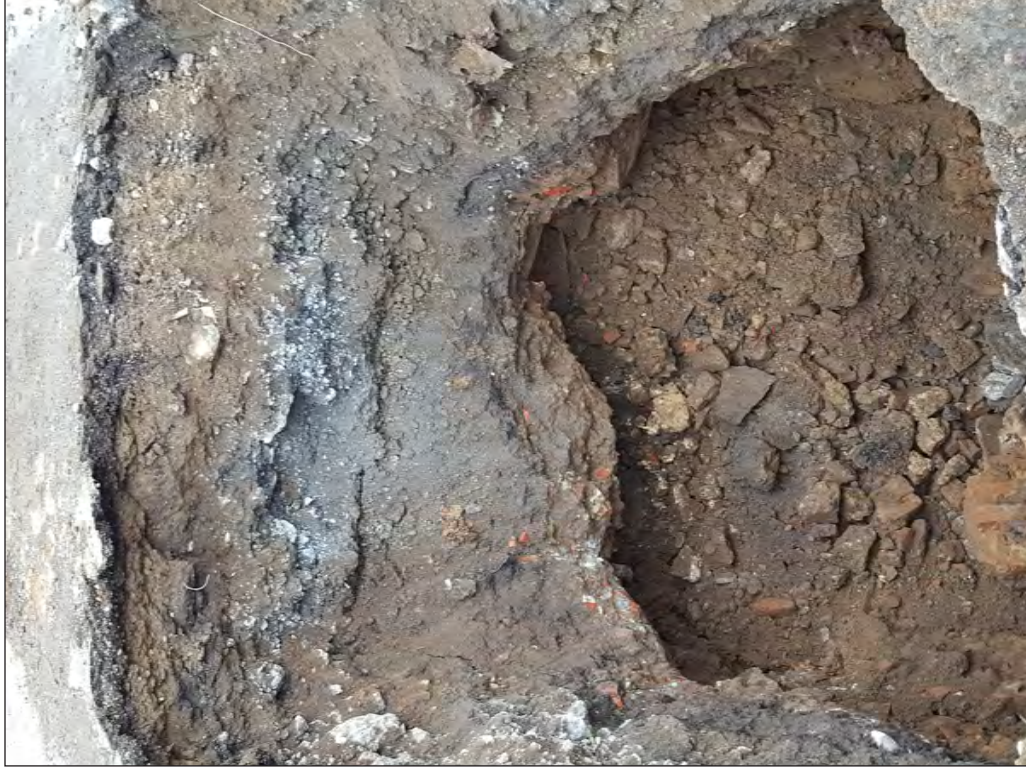
16
Facing south into TP3. Note multiple layers of fill and loose sandy fill at bottom.

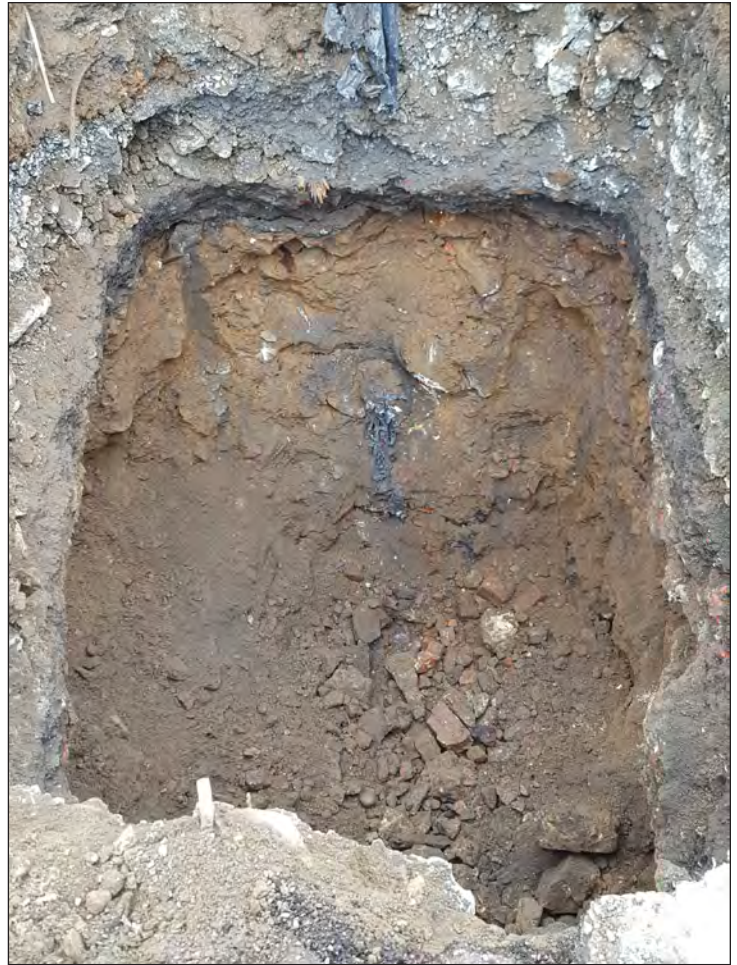
17

TP3 at completion. Bottom of trench is approximately 10 feet below the parking lot ground surface.

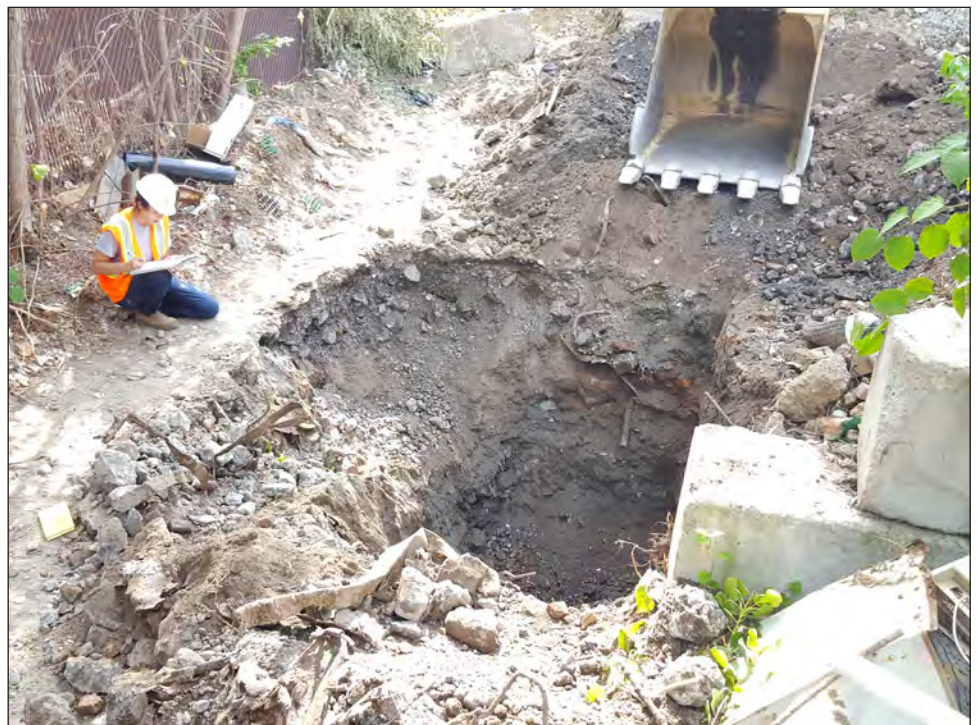
18

Facing east showing partially excavated TP4. Note loose sandy fills and modern refuse.

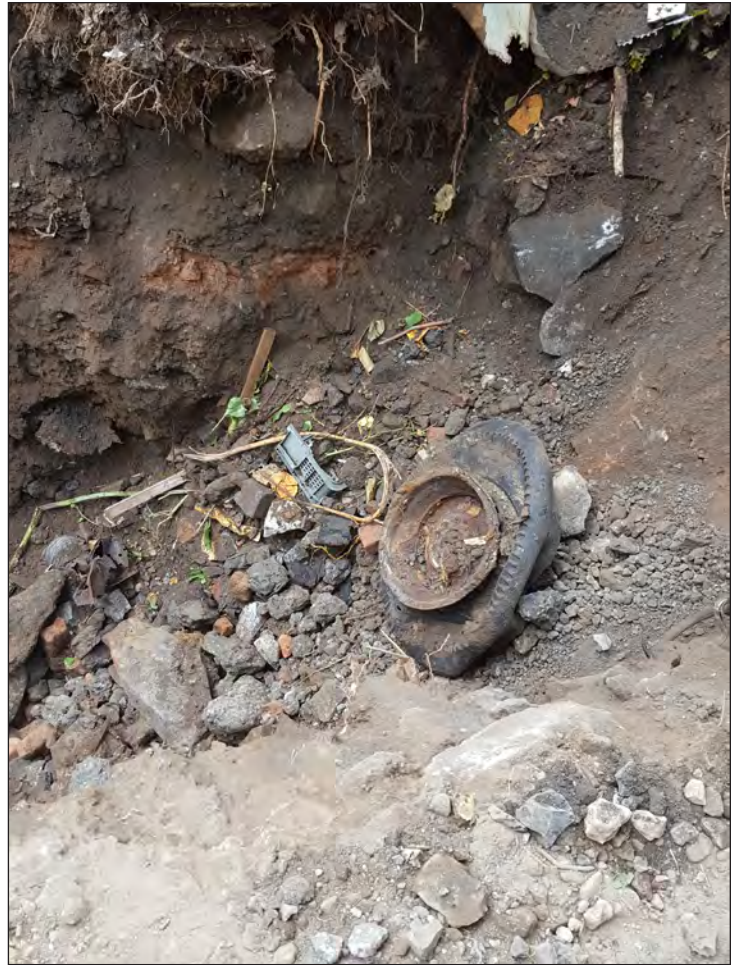
Modern refuse and car tire encountered in TP4. 19

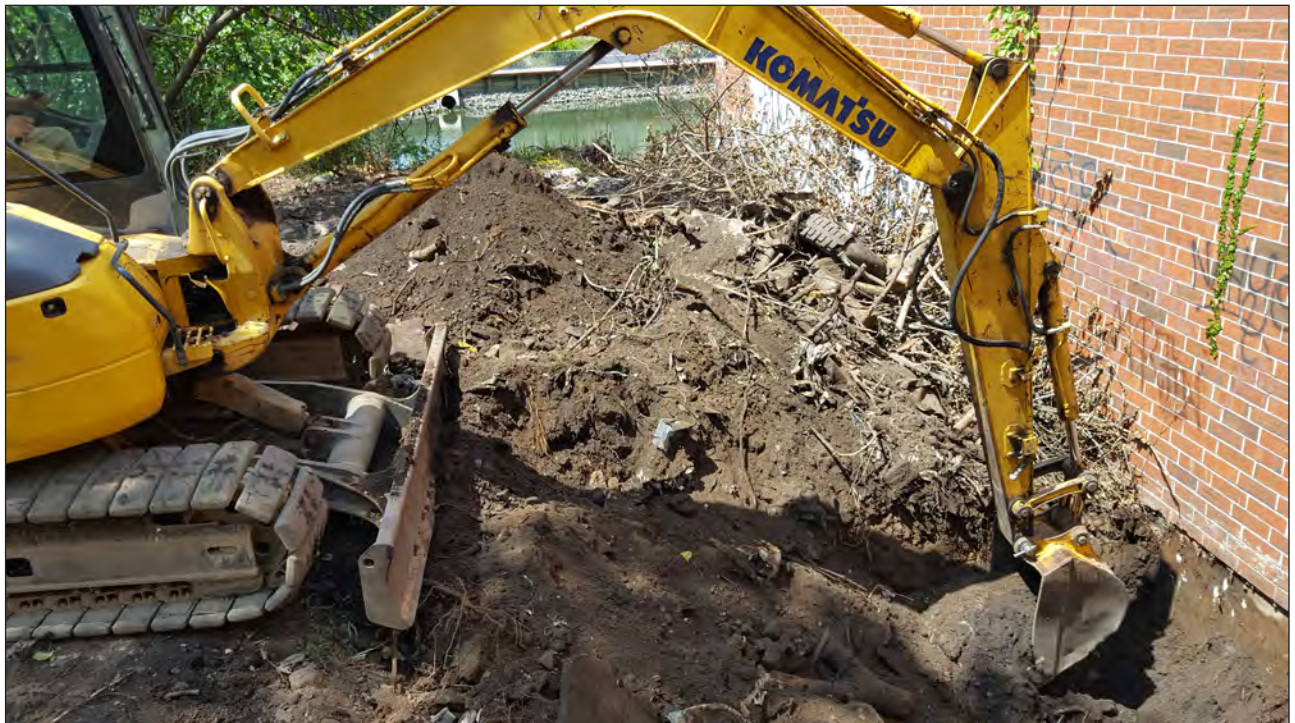
Facing west towards Gowanus Canal showing excavation of TP5 at base of brick building on right. 20

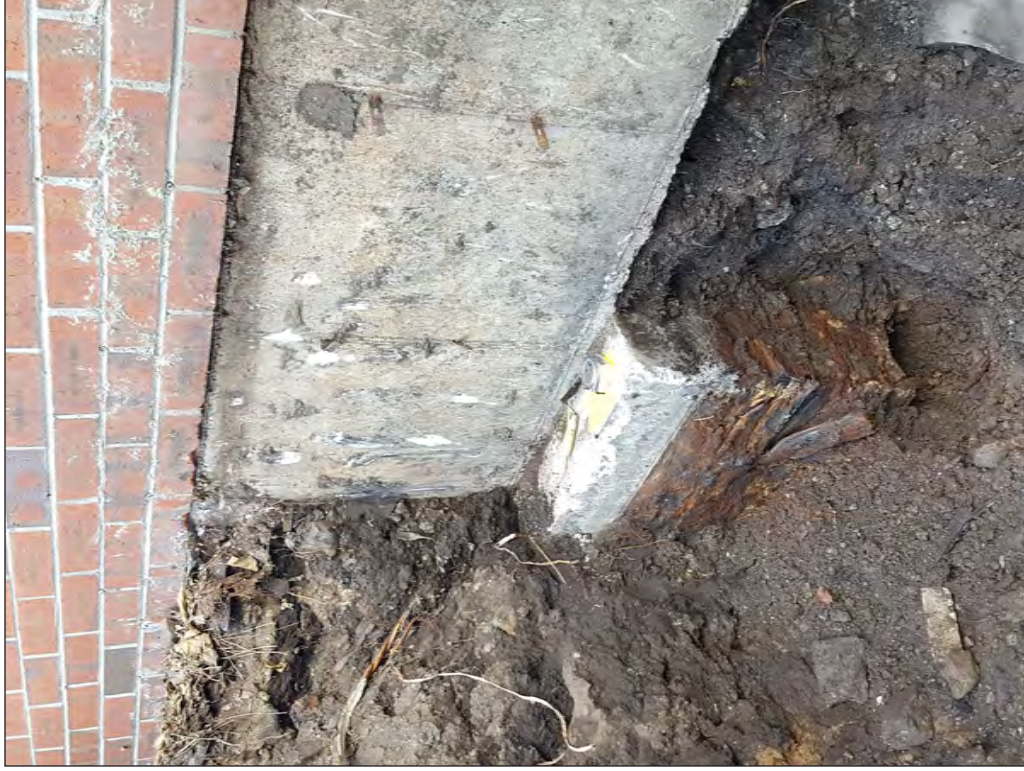
21
Facing northwest at building foundation at northern side of TP5.
Brick building is resting on a concrete foundation supported by a concrete footer within a matrix of mixed fill. Remains of the wooden form used to pour the concrete footer are still present.

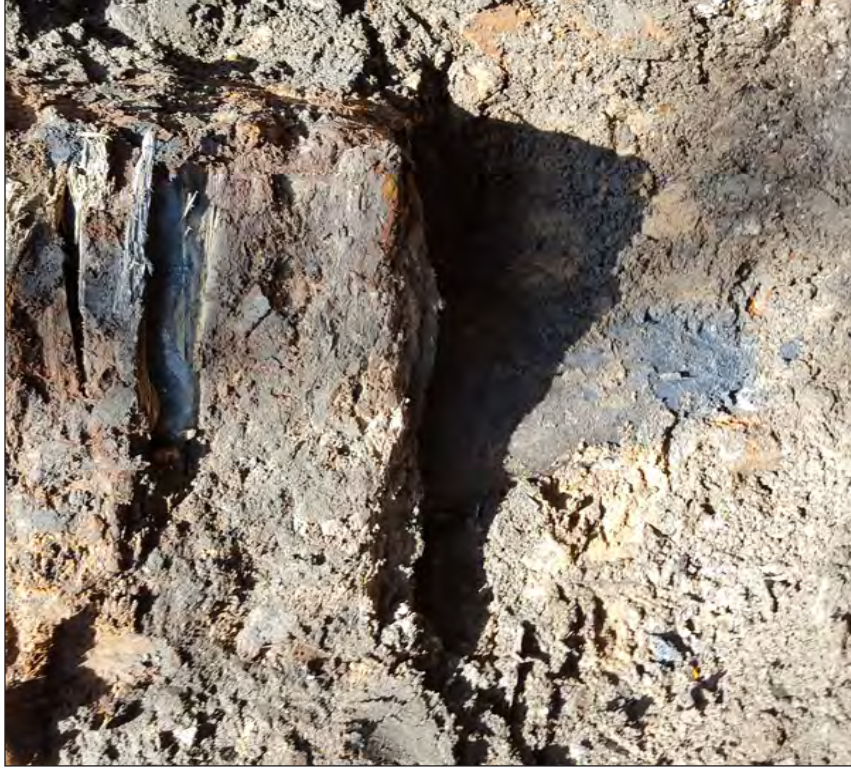
22
Facing northwest at building foundation at northern side of TP5
showing timber pile that is supporting the concrete footer.
Soils at bottom of photo are approximately
6.5 feet below base of brick building.

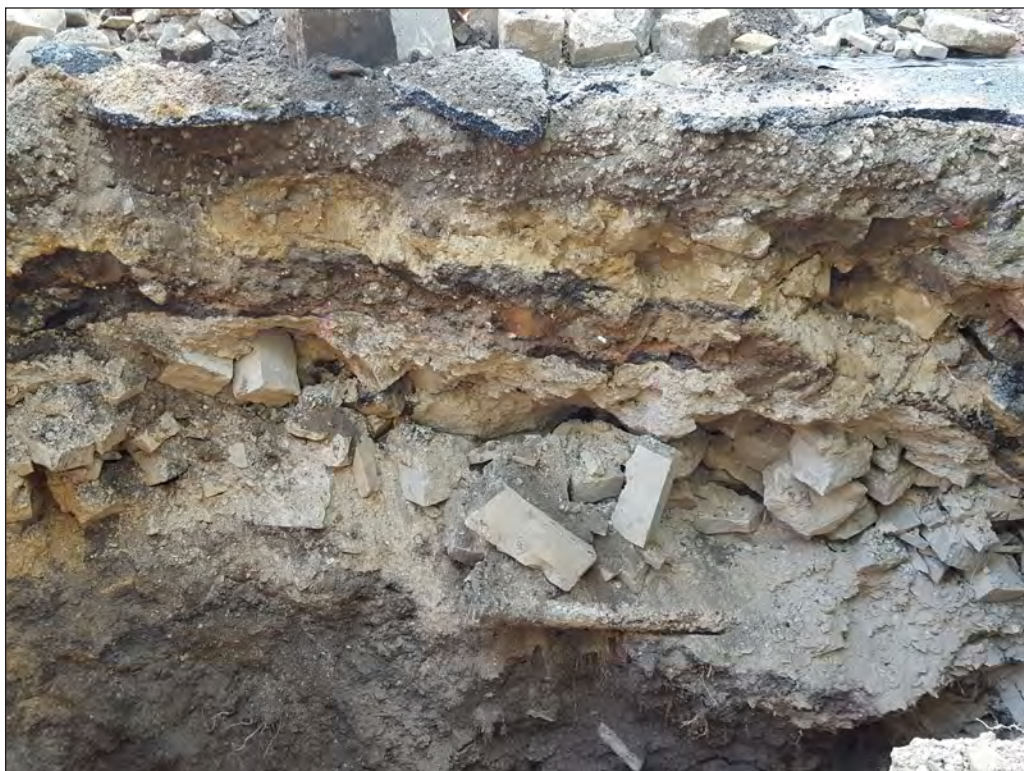
Photograph 23 - Facing west showing upper portion of western wall of Test Pit 6. Note multiple layers of loose fill and demolition debris. A 2-inch diameter pipe is located at the bottom of the photo.

Facing west showing upper portion of western wall of TP6. Note multiple layers of loose fill and demolition debris. A 2-inch diameter pipe is located at the bottom of the photo. **23**

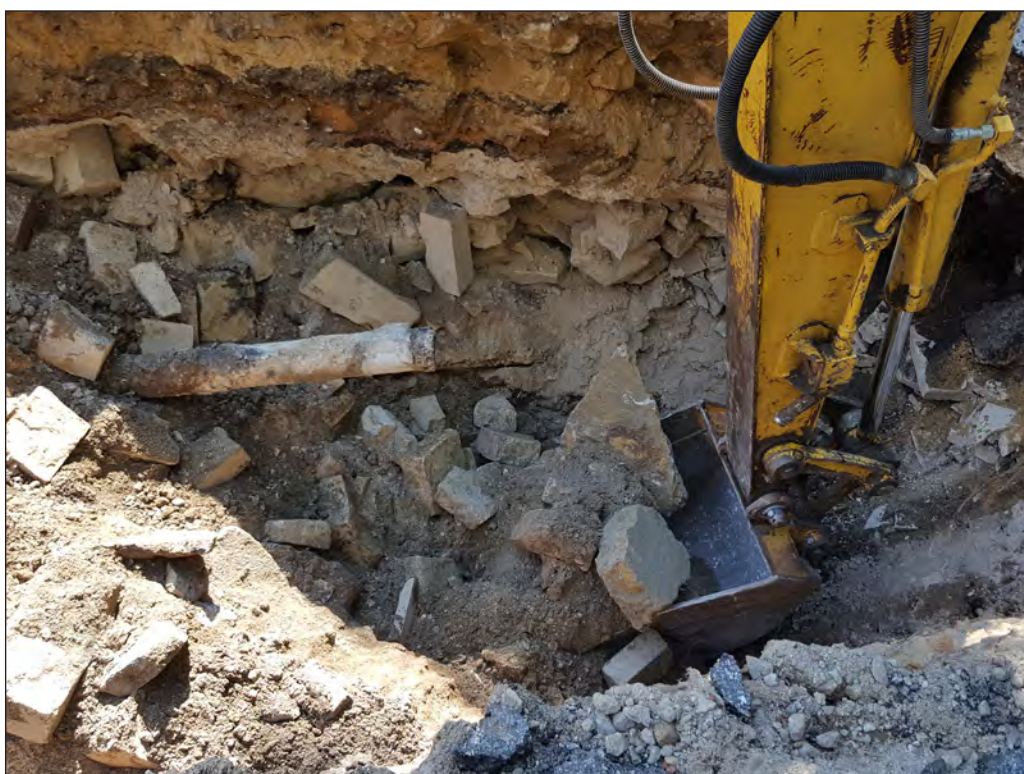
Photograph 24 - Facing west showing lower portion of western wall of Test Pit 6. Note multiple layers of loose fill and demolition debris. Note 6-inch diameter pipe extending into the test pit from the left. Base of trench is approximately 10 feet below ground surface in this photo.

Facing west showing lower portion of western wall of TP6. Note multiple layers of loose fill and demolition debris. Note 6-inch diameter pipe extending into trench from the left. Base of trench is approximately 10 feet below grade in this photograph. **24**
