**PRE-CONSTRUCTION CONDITION SURVEY REPORT  
420 CARROLL STREET, BROOKLYN, NEW YORK**

**PROJECT ID: PW77GOWAN  
EXCAVATION & CAPPING OF FILLED  
FIRST STREET TURNING BASIN, GOWANUS CANAL  
BROOKLYN, NEW YORK**

**November 30, 2017**

Re: Pre-Construction Condition Surveys  
420 Carroll Street (Block 453, Lot 1)

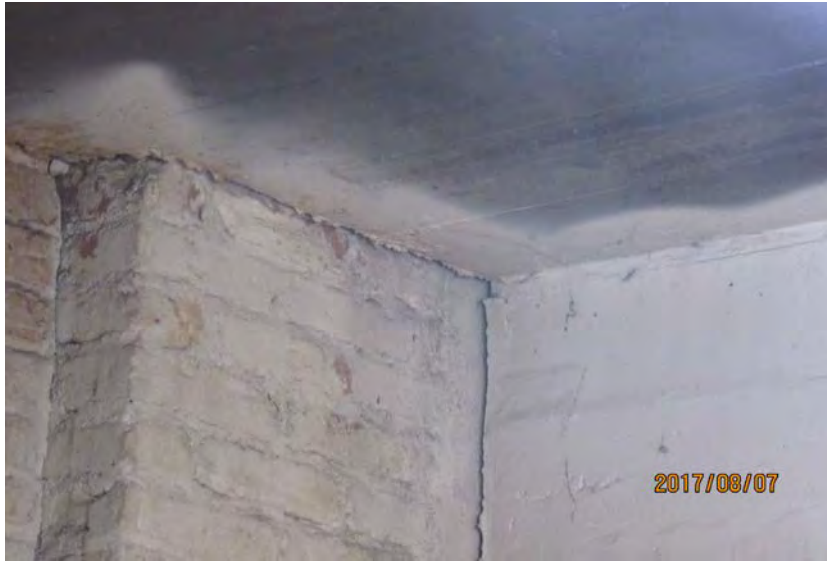
IMG\_5884.JPG

Floor / Location: 1st Floor Number of Windows 0  
 Room Use: Existing Storage 1 Ceiling:  Drywall  Suspended  Plaster  Wallpaper  Other Concrete  
 Walls:  Drywall  Paneled  Plaster  Wallpaper  Other Concrete  
 Photo(s):  Yes  No Floor:  Wood  Ceramic Tile  Other Tile  Other  
 Photo No's. 5876 ~ 5887  Concrete  Rug  Wall to wall carpet  
 OBSERVED DEFECTS:  None  Cracks (List size, type, location)  Other (Describe)  
 Comments: Ov. (5876), Dag Crk on Wall (5877, 5878), Vrt/Hz Crk (5879), Vrt Crk in Column (5880), Step crk corner of wall (5881), Step crk across hall (5882), Hole in wall (5883), Separation corner of wall (5884), Crk around door (5885, 5886, 5887),  
 See Comment No.

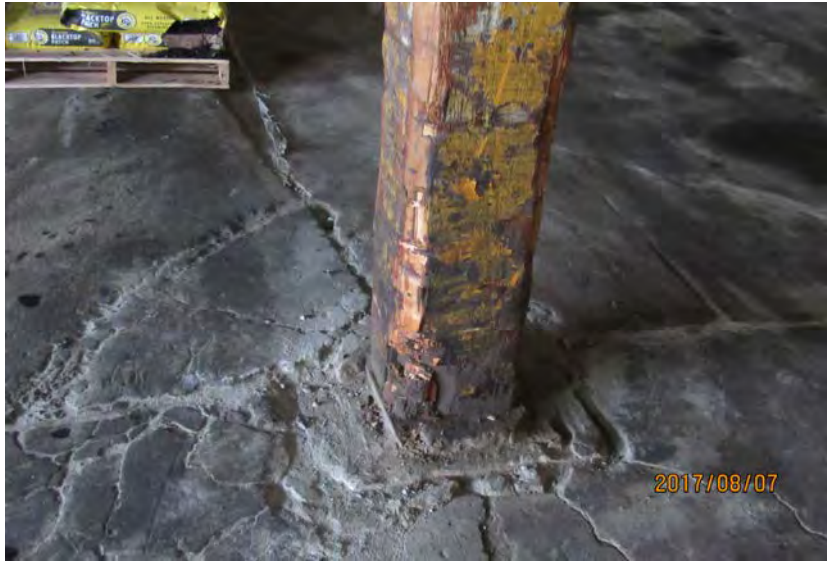
IMG\_5901.JPG

Floor / Location: 1st Floor Number of Windows 0  
 Room Use: Area 1 Ceiling:  Drywall  Suspended  Plaster  Wallpaper  Other open wood girders  
 Walls:  Drywall  Paneled  Plaster  Wallpaper  Other Concrete  
 Photo(s):  Yes  No Floor:  Wood  Ceramic Tile  Other Tile  Other  
 Photo No's. 5888 ~ 5920  Concrete  Rug  Wall to wall carpet  
 OBSERVED DEFECTS:  None  Cracks (List size, type, location)  Other (Describe)  
 Comments: Ov. (5888), Paint chipping (5889, 5890), Dag Crk (5891), Crk near column (5892), Damaged floor / Dag crk near column (5893), Damaged floor / Dag crk near column (5894, 5895, 5896, 5897, 5898), Vrt Crk (5899), Uneven floor; note; Wooden posts/columns, Chipped wood in column (5901),  
 See Comment No.

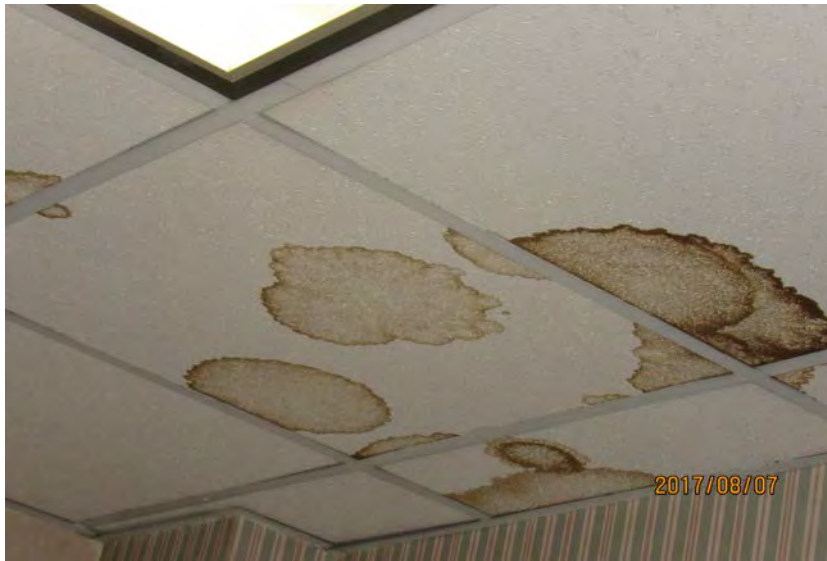
IMG\_6204.JPG

Floor / Location: 3<sup>rd</sup> Floor Number of Windows 2  
 Room Use: OFFICE 6 Ceiling:  Drywall  Suspended  Plaster  Wallpaper  Other  
 Walls:  Drywall  Paneled  Plaster  Wallpaper  Other  
 Photo(s):  Yes  No Floor:  Wood  Ceramic Tile  Other Tile  Other  
 Photo No's: 6204 ~ 6206  Concrete  Rug  Wall to wall carpet  
 OBSERVED DEFECTS:  None  Cracks (List size, type, location)  Other (Describe)  
 Comments: OV (6204), Water staining on ceiling (6205), Puncture d wall (6206),  
 See Comment No.

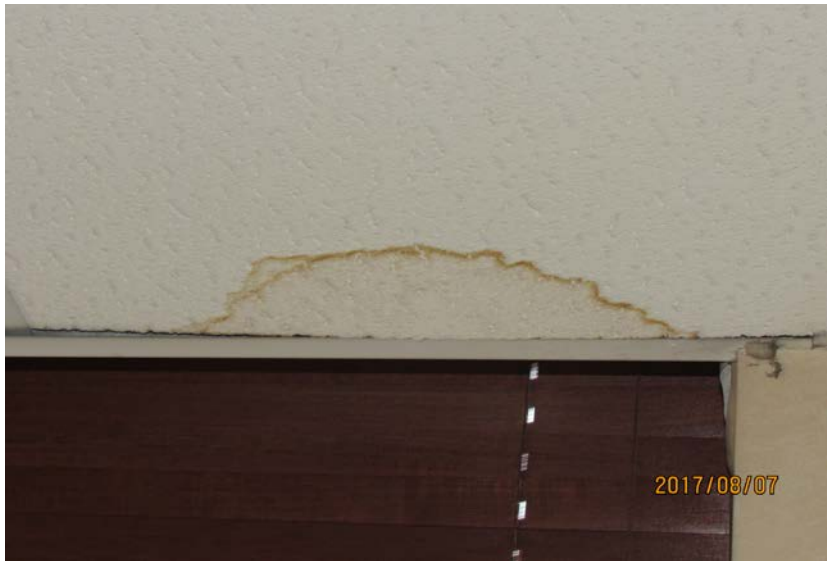
IMG\_6208.JPG

Floor / Location: 3<sup>rd</sup> Floor Number of Windows 1  
 Room Use: OFFICE 7 Ceiling:  Drywall  Suspended  Plaster  Wallpaper  Other  
 Walls:  Drywall  Paneled  Plaster  Wallpaper  Other  
 Photo(s):  Yes  No Floor:  Wood  Ceramic Tile  Other Tile  Other  
 Photo No's: 6207 ~ 6210  Concrete  Rug  Wall to wall carpet  
 OBSERVED DEFECTS:  None  Cracks (List size, type, location)  Other (Describe)  
 Comments: OV (6207), Patched hole in ceiling (6208), Water stain in ceiling (6209), Peeling wallpaper (6210),  
 See Comment No.

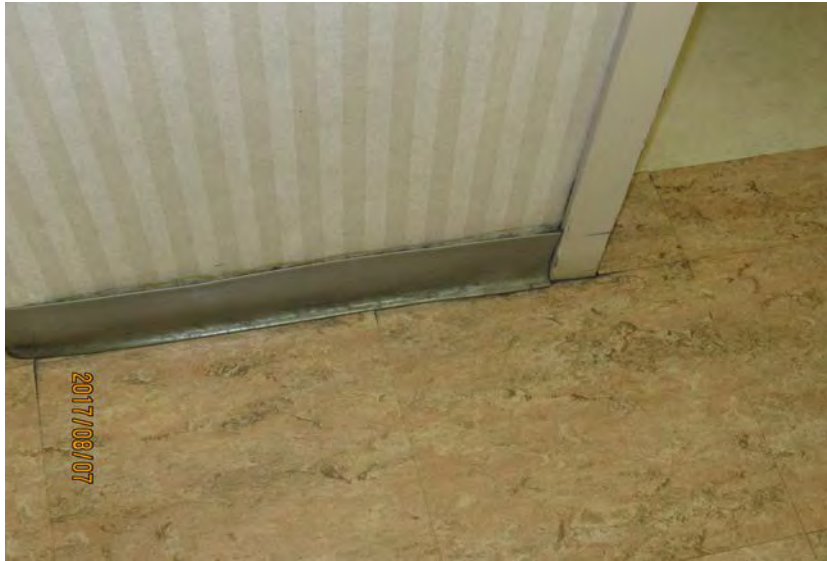
IMG\_6222.JPG

Floor / Location: 3<sup>rd</sup> Floor Number of Windows 0  
 Room Use: OPEN OFFICE AREA Ceiling:  Drywall  Suspended  Plaster  Wallpaper  Other  
 Walls:  Drywall  Paneled  Plaster  Wallpaper  Other  
 Photo(s):  Yes  No Floor:  Wood  Ceramic Tile  Other Tile  Other VINYL  
 Photo No's: 6211 ~ 6241  Concrete  Rug  Wall to wall carpet  
 OBSERVED DEFECTS:  None  Cracks (List size, type, location)  Other (Describe)  
 Comments: OV (6211), Peeling wallpaper (6214), Chip in ceiling (6215),  
 Water staining (6212), Hole in ceiling (6213), Floor board sep (6217, 6218, 6219),  
 Water staining (6220), Hole in ceiling (6221), Damaged floor (6222),  
 Floor board sep (6223, 6224, 6225, 6226),  
 See Comment No.

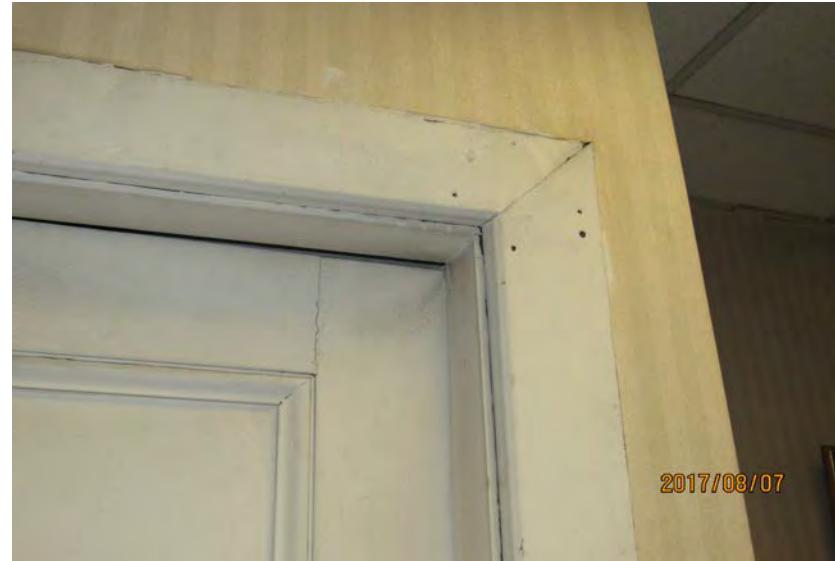
IMG\_6239.JPG

Floor / Location: CONTD. FROM PREVIOUS Number of Windows 0  
 Room Use: Ceiling:  Drywall  Suspended  Plaster  Wallpaper  Other  
 Walls:  Drywall  Paneled  Plaster  Wallpaper  Other  
 Photo(s):  Yes  No Floor:  Wood  Ceramic Tile  Other Tile  Other  
 Photo No's:  Concrete  Rug  Wall to wall carpet  
 OBSERVED DEFECTS:  None  Cracks (List size, type, location)  Other (Describe)  
 Comments: 6227, 6228, Water staining (6229), Floor board sep (6230, 6231, 6232, 6233, 6234, 6235, 6236, 6237), Peeling wall paper column (6238),  
 Skylight vent: note Sep around door (6239, 6240), Damage vinyl floor (6241)  
 See Comment No.

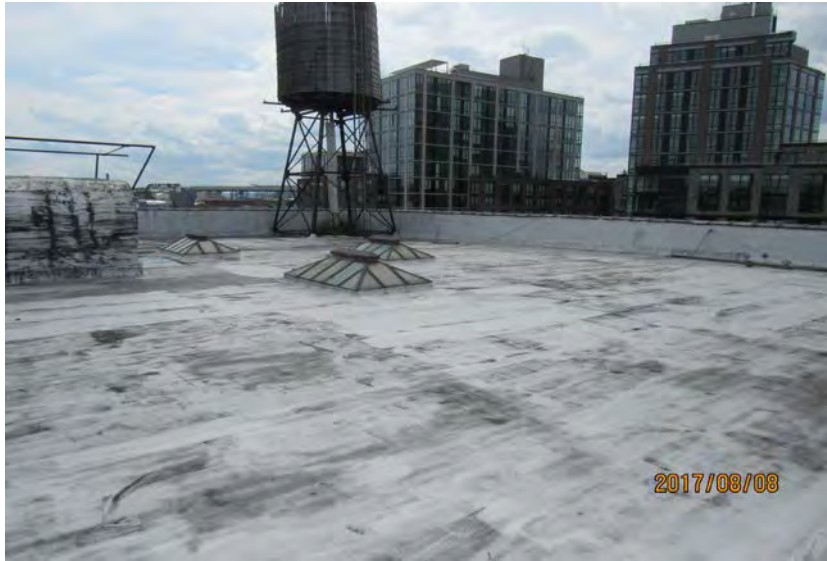
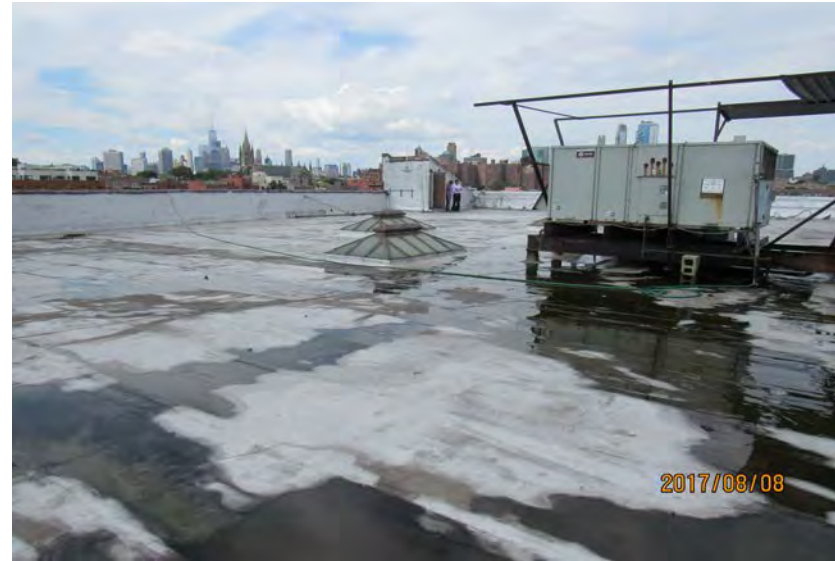
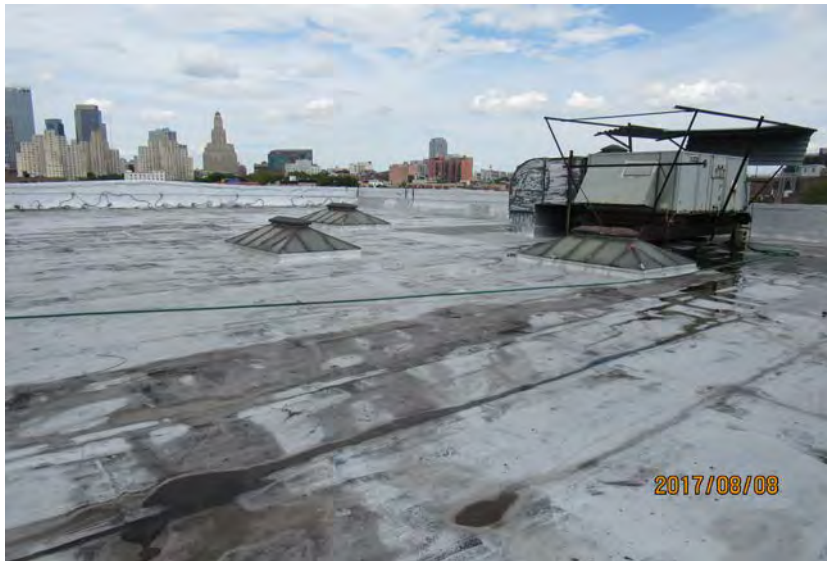
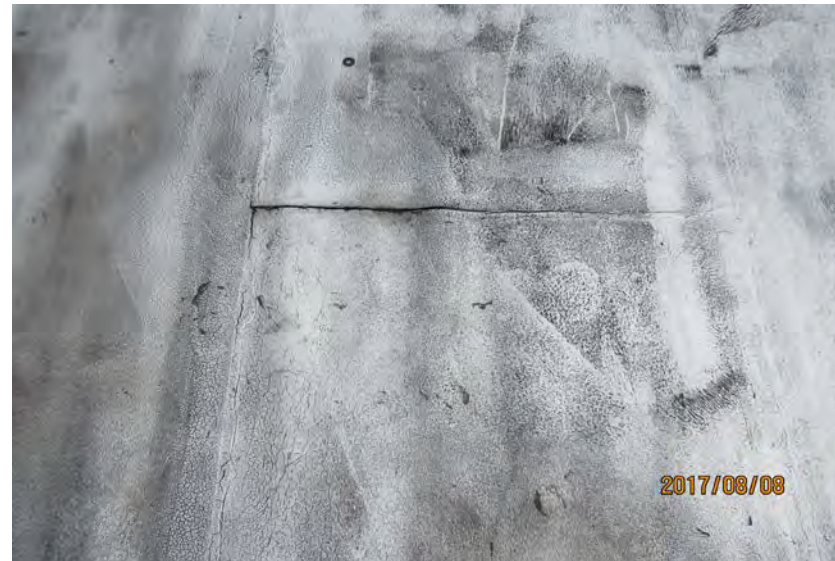
OV (6597-6600), sep. rolled roof (6601), rick corner (6602), up (6603), rick corner (6604),  
broken glass vent (6605/6606), repeated roof top deterioration damage (6607)

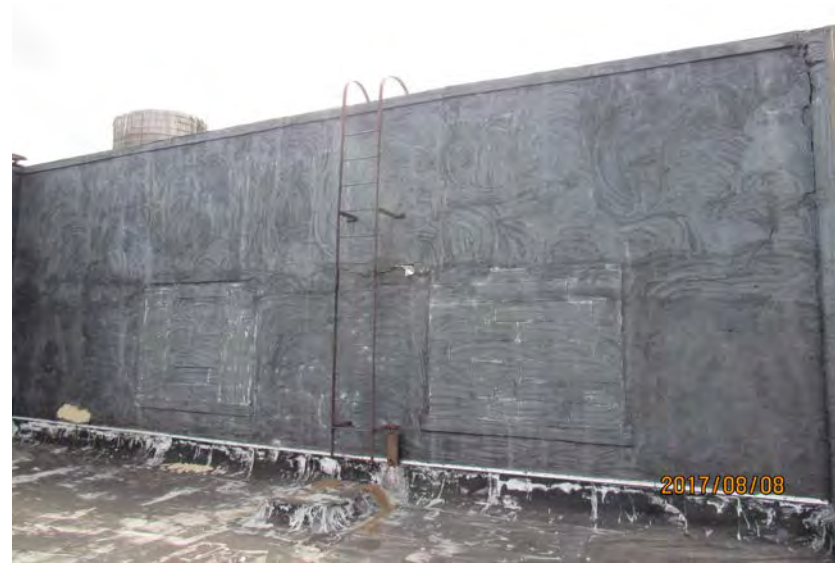
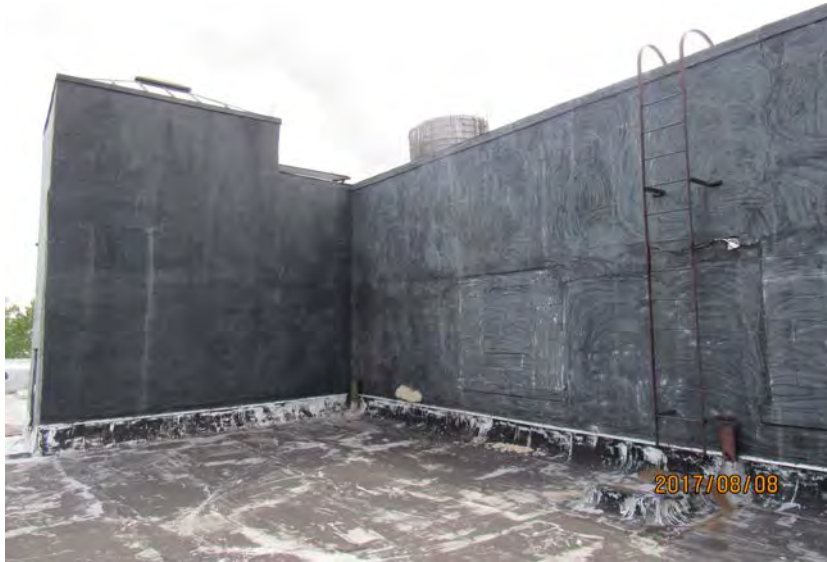
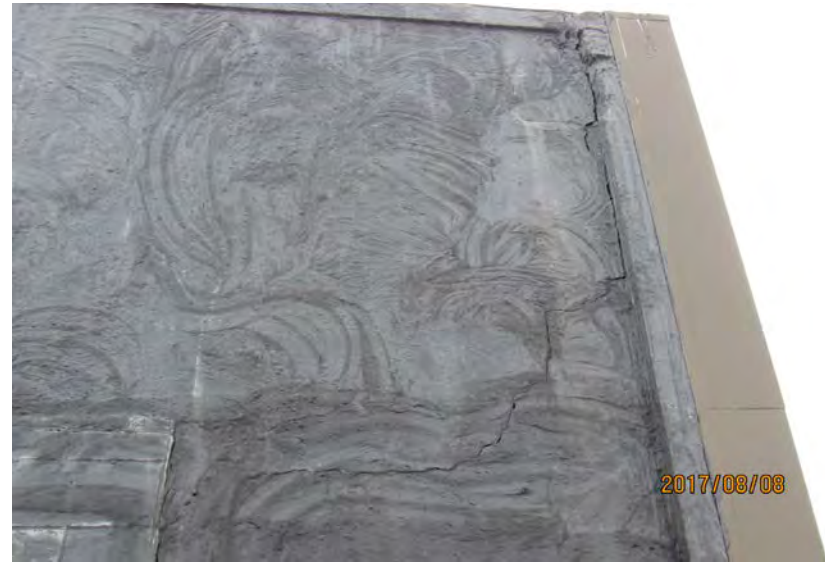
OK (6608-6610), r/a. & stepped cills on wall (6611-6616), damage in wall (6617, 6618), cracks and separation @ parapet (6619-6622)

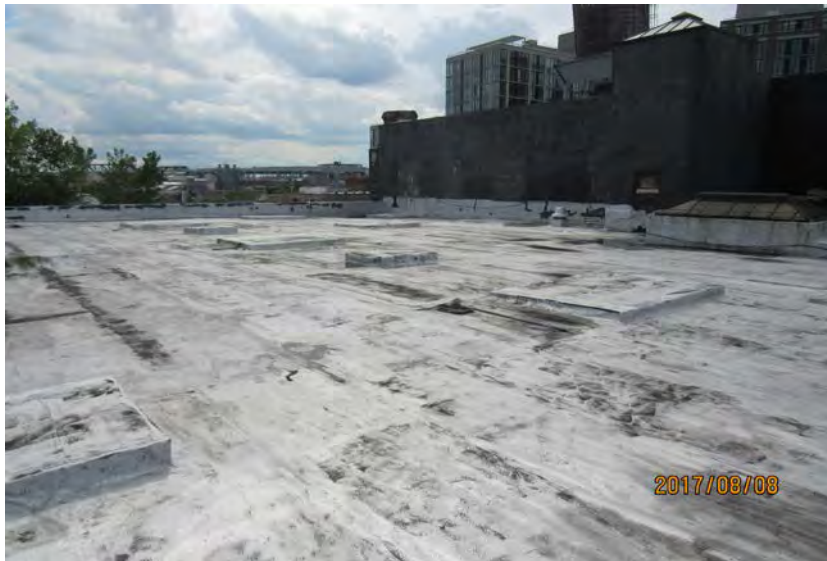
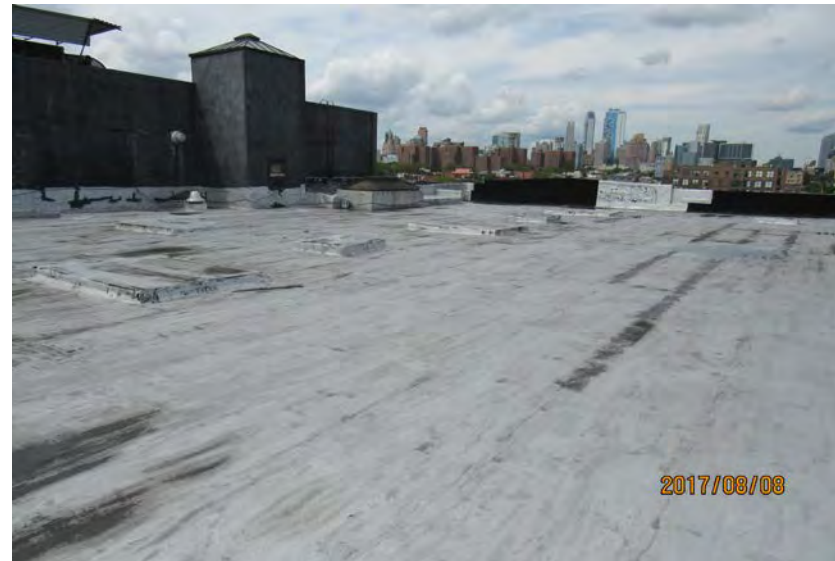
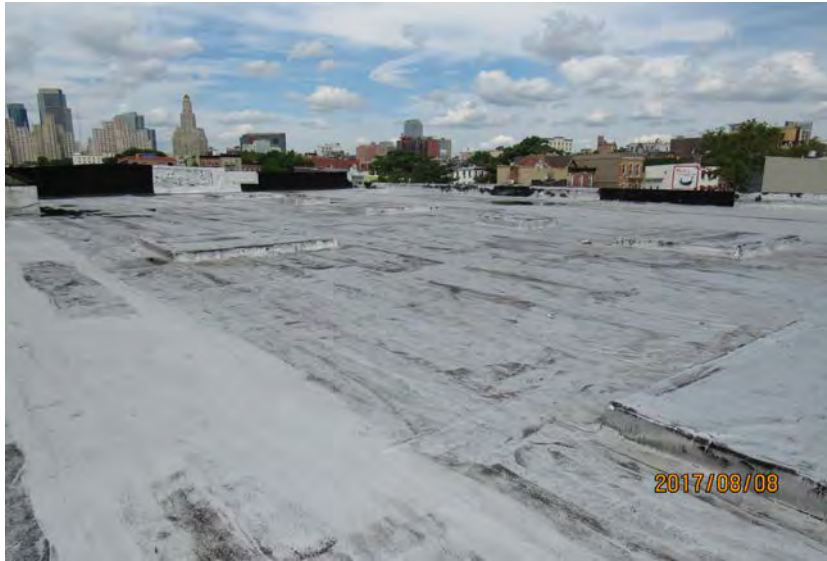
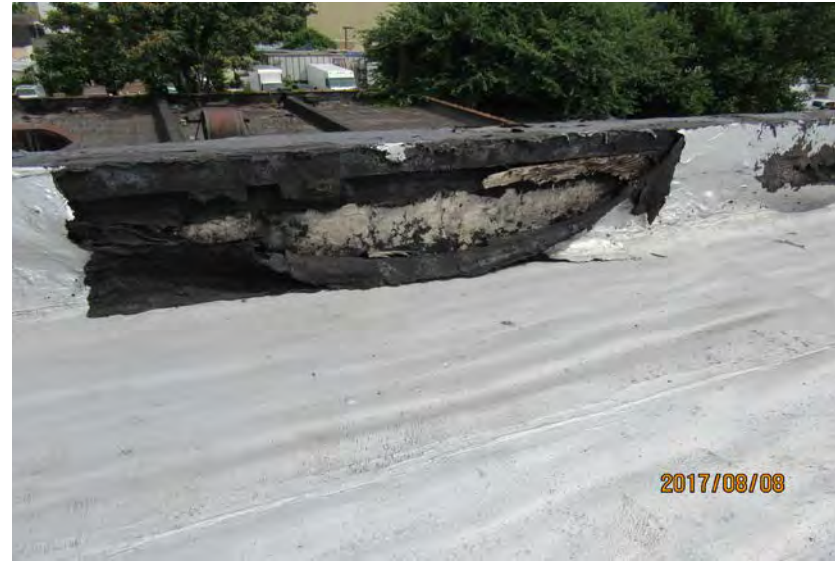
OV(6623-6626) damage of aluminum (6627-6634), OV(6635-6638), OV(6639), Crk wall(6640-6646), ponding (6631), crk wall(6647), NOTE: uneven Prof.
