Memorandum

Subject: TB4 Pilot Study Observations during Bulkhead Support Installation

TB4 PILOT STUDY OBSERVATIONS AND FUTURE DESIGN IMPACTS:

GIKEN TRIAL

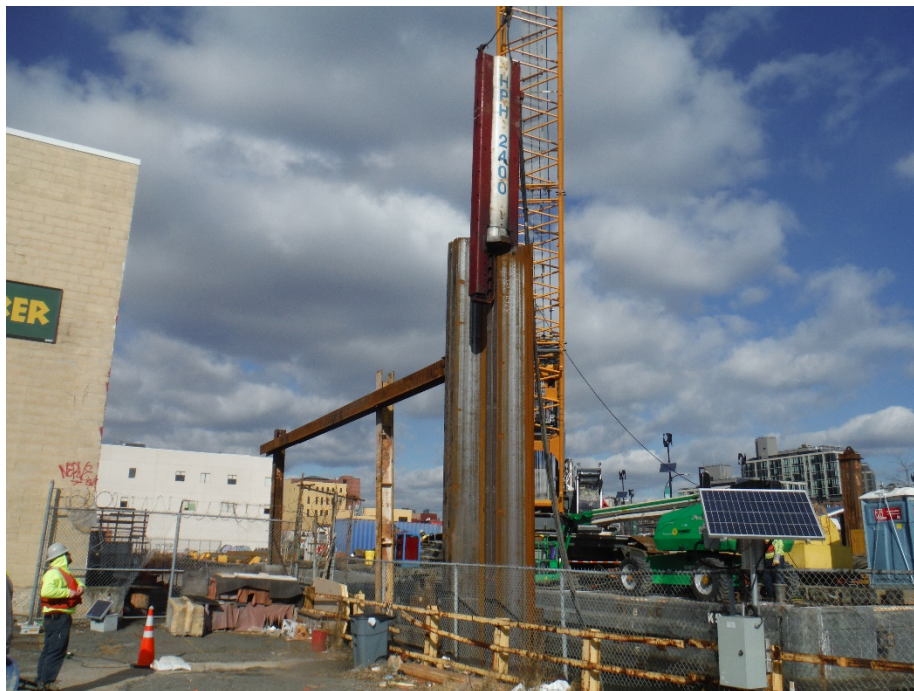
- Hydraulic impact hammers create vibrations that can cause movement of existing bulkheads.** A hydraulic impact hammer (Dawson HPH2400) was utilized in an attempt to reduce pile installation noise and vibrations. The hammer was tested at various stroke heights to identify the most efficient method of pile driving that did not cause excess vibrations. At a low stroke height, the hammer could not effectively drive the sheet piles through the glacial deposits which underlay the native alluvial sediments. At the mid-range stroke height, the sheet piles could be driven to target depths; however, settlement and displacement of the existing bulkhead was observed. Movements at the optical survey markers were similar in behavior to what was observed during vibratory pile driving, as shown in Figure 3 and Figure 4. As was the case for vibratory driving, it appeared that movements continue for some time after pile driving and it was unclear as to within which soil unit(s) movements were occurring. Structures within 20 ft of the pile driving, including those both in fair and poor condition, also developed signs of movement. The high number of blow counts required to drive the sheets caused the tops of the sheets piles to crush and disfigure. Additionally, the contractor had less control on the location and alignment of the piles installed and therefore required additional falsework as compared to vibratory sheet pile installation, as shown in Figure 5. The additional falsework reduced the production rate for sheet pile installation. Based on the observations made during the Pilot Study, hydraulic impact hammering should not be used for sheet pile installation

Figure 5. Example of Impact Hammer Pile Driving

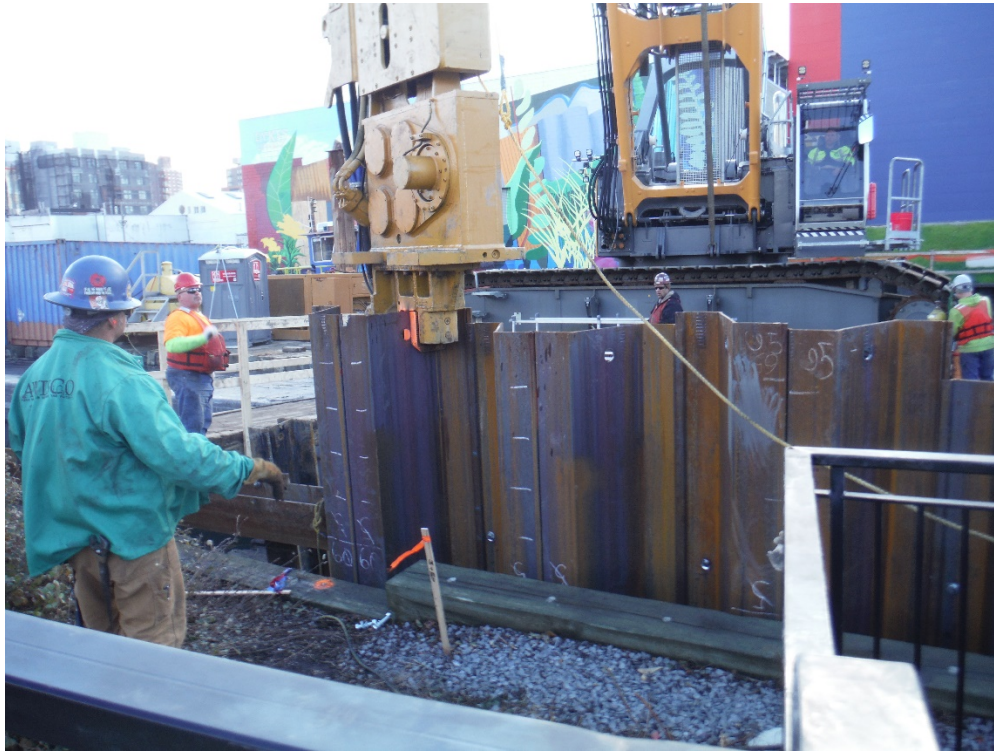
- **Pitch and drive method requires careful execution.** EPA directed following the “pitch and drive” method for driving sheet piles, with piles being driven one at a time instead of in pairs. An example of the pitch and drive method is shown in **Figure 7**. In the photo, the leading pile is being driven while the previously driven piles are held together and bolted to the guide waler beam. This method involved driving one sheet at a time to target depth in sequence along the wall alignment. This method helped reduce noise during installation but not to decibel levels below target; however, it provided less control on sheet pile alignment. Several sheet piles had to be removed and reset to maintain pile alignment. Pulling sheet piles and re-driving caused additional vibrations that induced additional settlement and displacement of existing bulkheads. The areas of greatest settlement have been observed in areas with the longest durations of driving. To limit vibration exposure, piles cannot be allowed to go out of alignment thus requiring to be reset; therefore, extra care and falsework should be required to limit the potential for pile misalignment.

Figure 7. Example of Pitch and Drive Pile Installation

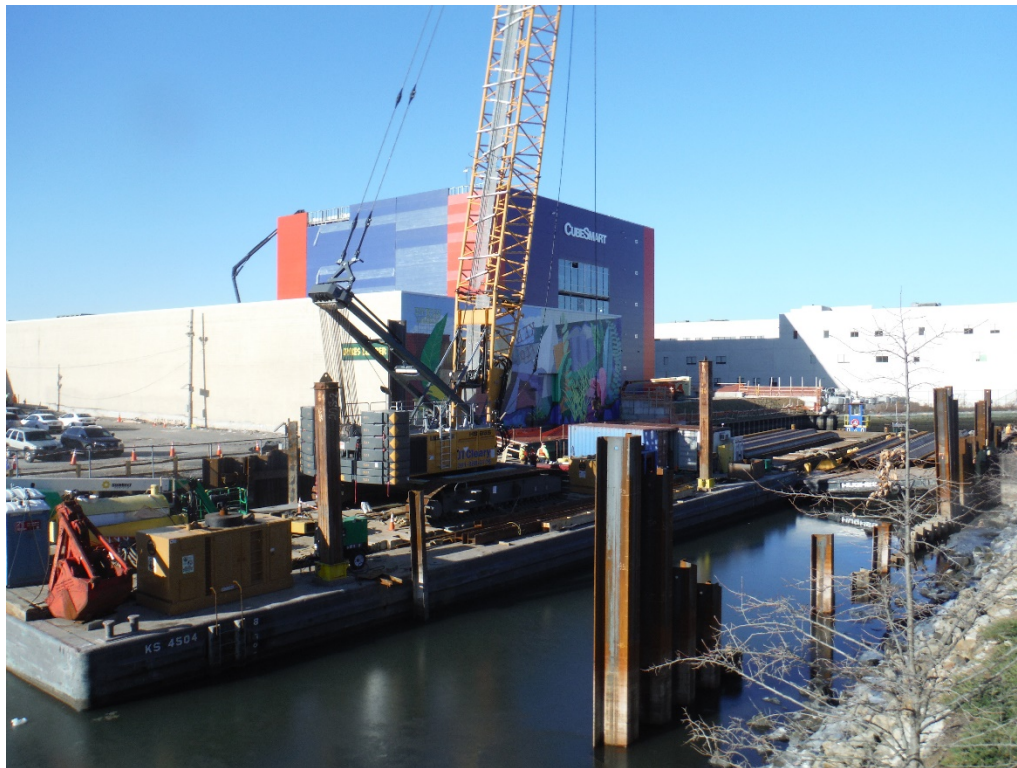
- **The long and heavy sheet piles required for a cantilevered wall are logistically more challenging to install and installation can impact a larger area than the sheet piles necessary for an anchored wall.** The sheet piles required to provide temporary cantilevered support to the existing bulkheads are on average 50% longer (65 ft vs. 45 ft length) and weigh 80% more on a per sheet basis because the sheets are thicker and longer than the typical sheet piles used as part of a permanent anchored bulkhead replacement systems along the Canal. The size and weight of cantilevered sheets created logistical challenges.

Figure 8. Photo of the Crane and Barges Necessary to Perform the Sheet Pile Installation

In areas that require a large cantilevered sheet pile, it is recommended that alternative methods to the conventional pile driving be implemented, such as the press pile method and the auger and press method. However, the sheet piles require deep embedment and may require driving through a stratum of dense gravel which can inhibit the sheet pile installation rate (see Attachment B).

Alternatively, it is recommended that in areas that can accommodate an anchored wall and where necessary additional access can be obtained, that it be considered instead of a cantilevered system because conventional construction methods may be implementable.

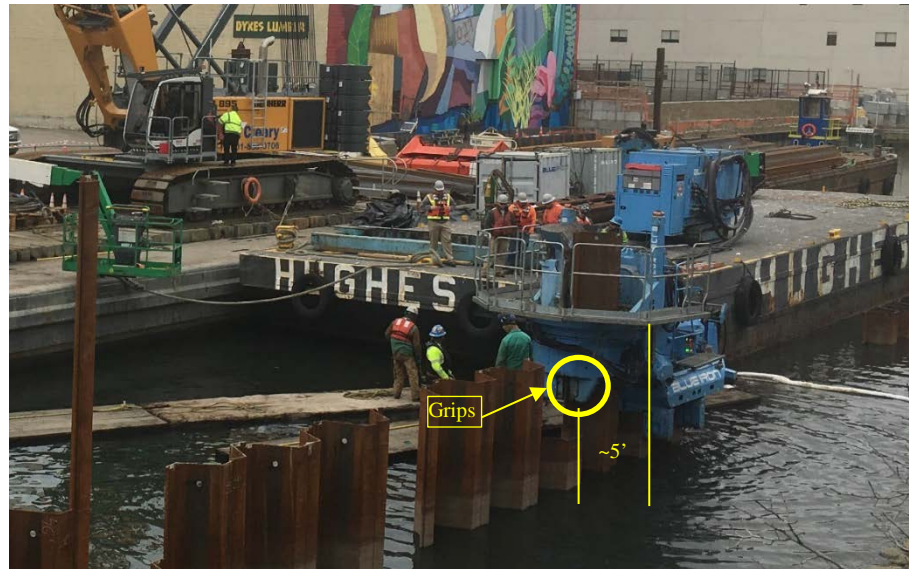
- **The Giken equipment requires open space to operate.** The machine requires at least five ft of open space on either side of a pile so that a platform can be used around the machine's head to provide crew access for setting piles through the machine's grip. See Figure 1. Furthermore, the machine's grips need two to three ft of clearance on either side to be able to maneuver around the pile tops and must also be kept away from the Canal's brackish water because the water can cause corrosion of the sensitive grips. The best approach for providing adequate space for the equipment is to set the pile tops at an elevation high enough that the top of the existing bulkhead can be cleared by the machine's grips.

Figure 1. Photo of Giken Set on Sheet Pile

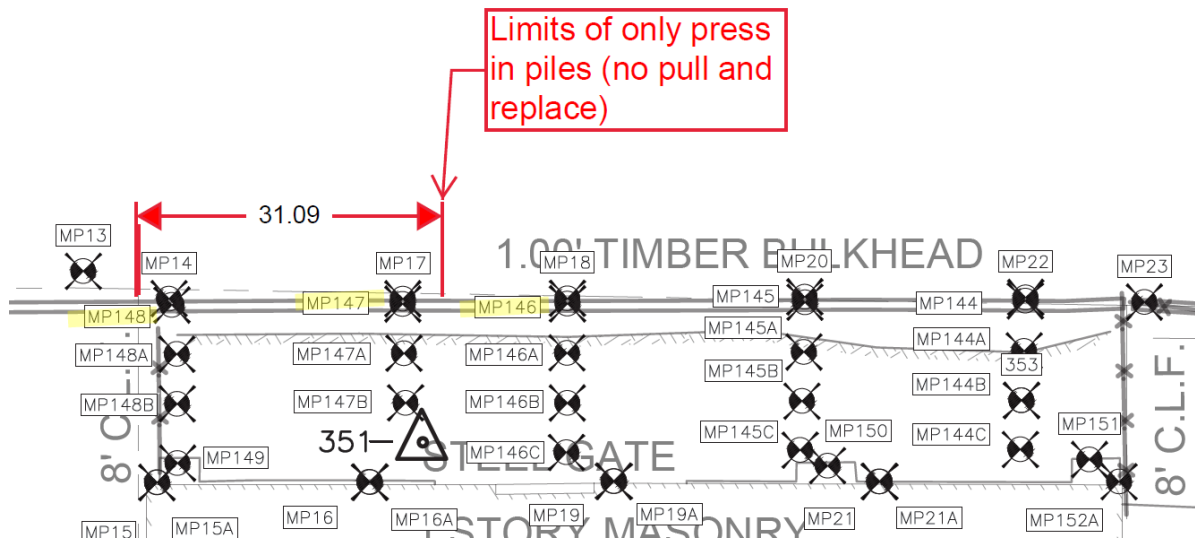
- **The press method can cause movements of adjacent existing bulkheads.** Throughout installation, the press method produced less vibration than press and auger method; however, movements of existing bulkheads were still observed on occasion. During driving at Dykes Lumber movement was observed in both areas where existing piles were pulled and replaced, and in areas where piles were only replaced (no existing piles required removal). An example area of where only pile installation with the press method is shown in Figure 7. The measured movements are presented in Figure 8 and Figure 9 near MP-147. MP-147 and MP-147A represent optical survey points on the existing bulkhead and MP-16A represents a point on the Dykes Lumber structure's foundation. At these monitoring points it was observed that the existing bulkhead shifted downward and towards the Canal on April 18th. On this date, six pile pairs were pressed. The pile installation process observed on this date was similar or faster (lower resistance) than that observed on previous days, with no indication of encountered obstructions in shallow reaches and hard driving not being encountered until elevation -50 or deeper. Therefore, the mechanism and cause of the movement is unclear. Additional movements at points near MP-147 are shown in Figures 10 and 11.

Figure 7. Monitoring Point Location Plan along Dykes Lumber
