**PRE-CONSTRUCTION CONDITION SURVEY REPORT
338 THIRD AVENUE, BROOKLYN, NEW YORK**

Re: Pre-Construction Condition Surveys
338 Third Avenue (Block 967, Lot 24)

PRE-CONSTRUCTION CONDITION SURVEY

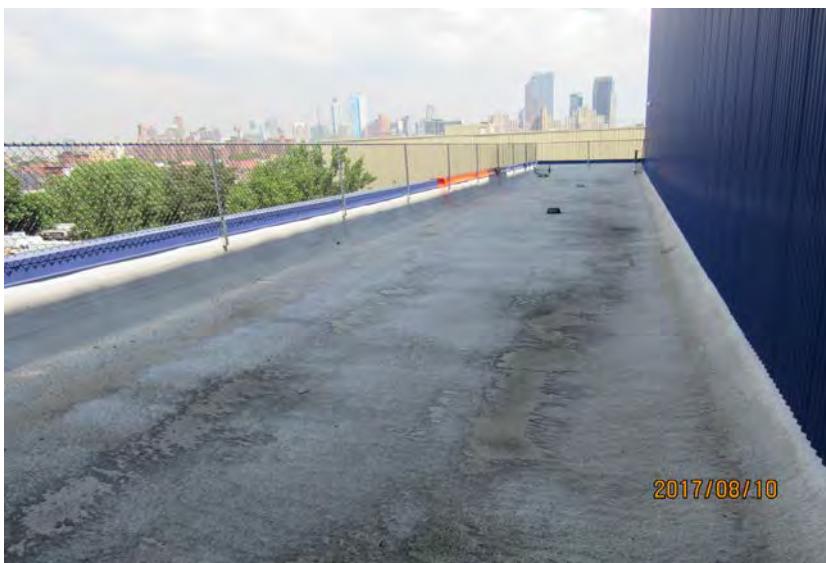
IMG_7168.JPG

On (7168, 7169), water staining (7170)

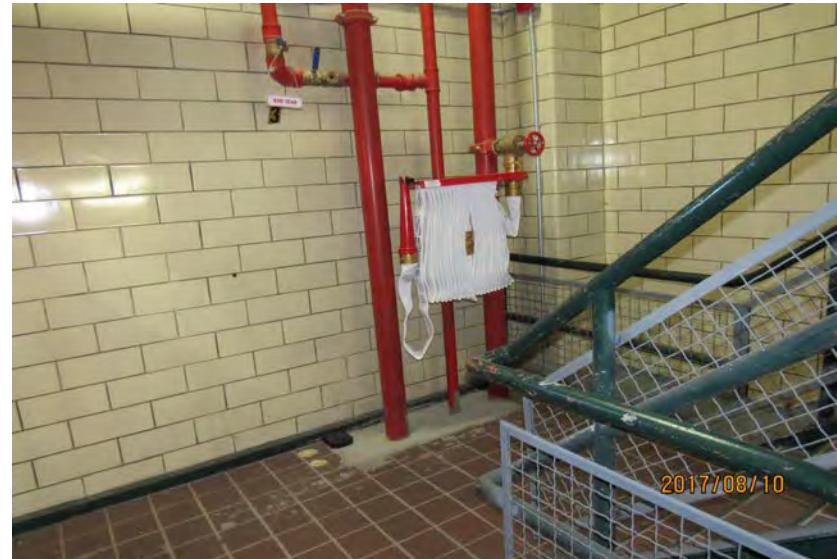
IMG_7359.JPG

None Cracks (List size, type, location) Other (Describe)Comments: Ov (7359) ^{ver}, Crk tile (7360) See Comment No.

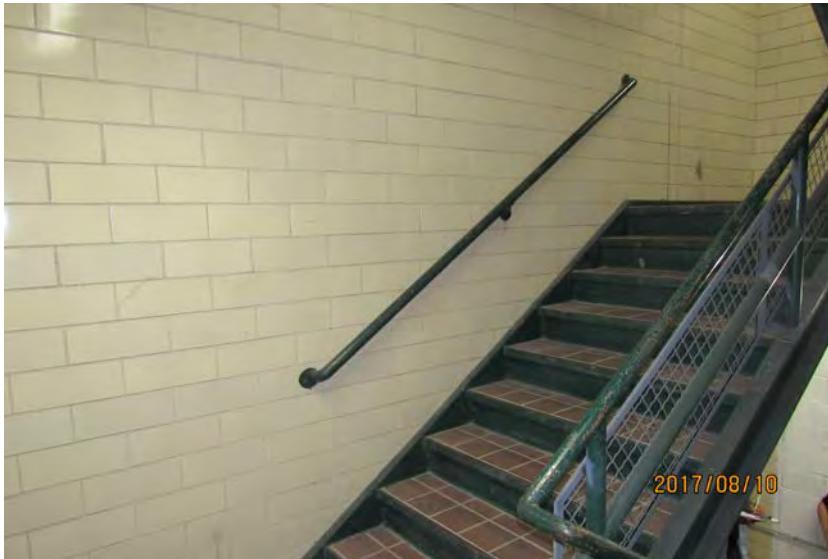
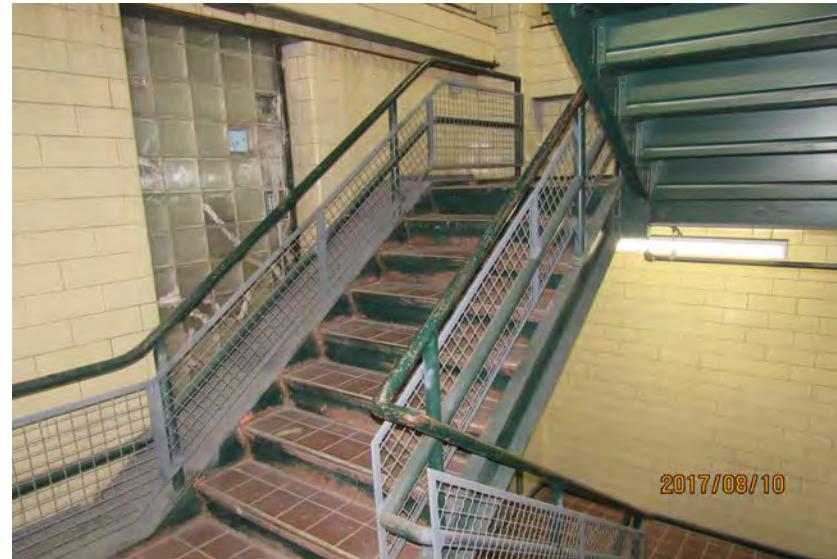
Comments: OV (7389 ~ 7392), Crk tile (7393 ~ 7398), crk window block (7399 ~ 7400), water staining (7396)
